VISUAL BUILDING and PEST INSPECTION REPORT	5
ROOF SYSTEM EXTERNAL	8
EXTERIOR	9
INTERIOR CONDITION REPORT	10
STAIRS INTERNAL	19
BATHROOMS	20
TOILETS	27
LAUNDRY	32
KITCHEN	34
DECKS, PERGOLAS, BALCONIES, VERANDAHS, AWNINGS	36
GARAGING	37
ROOF SYSTEM INTERNAL	38
FOOTINGS	41
SITE	41
SERVICES	42
Important Information	47
VISUAL TIMBER PEST INSPECTION PART 2 of REPORT	51
BRIEF SUMMARY	53
ROOF	54
INTERIOR	56

Complete Asset Report Example Qld

0214 Marketing Report bldpst

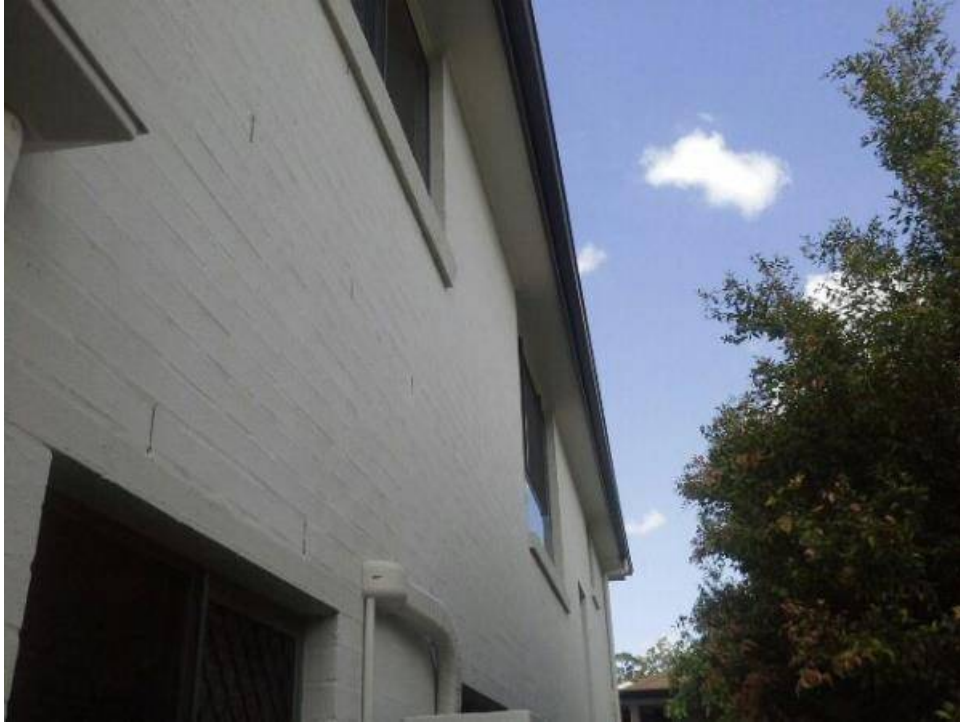
The eaves are lined with fibre cement sheeting. The overall condition of the eaves lining is good.

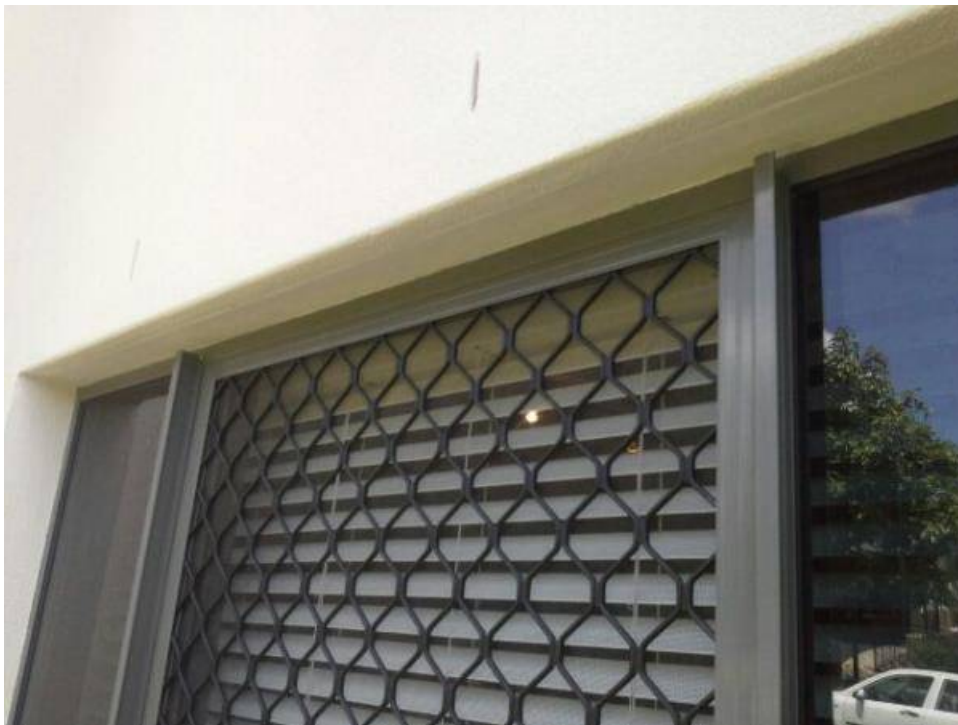
The lintels are of galvanised steel, The condition of the lintels is generally good.

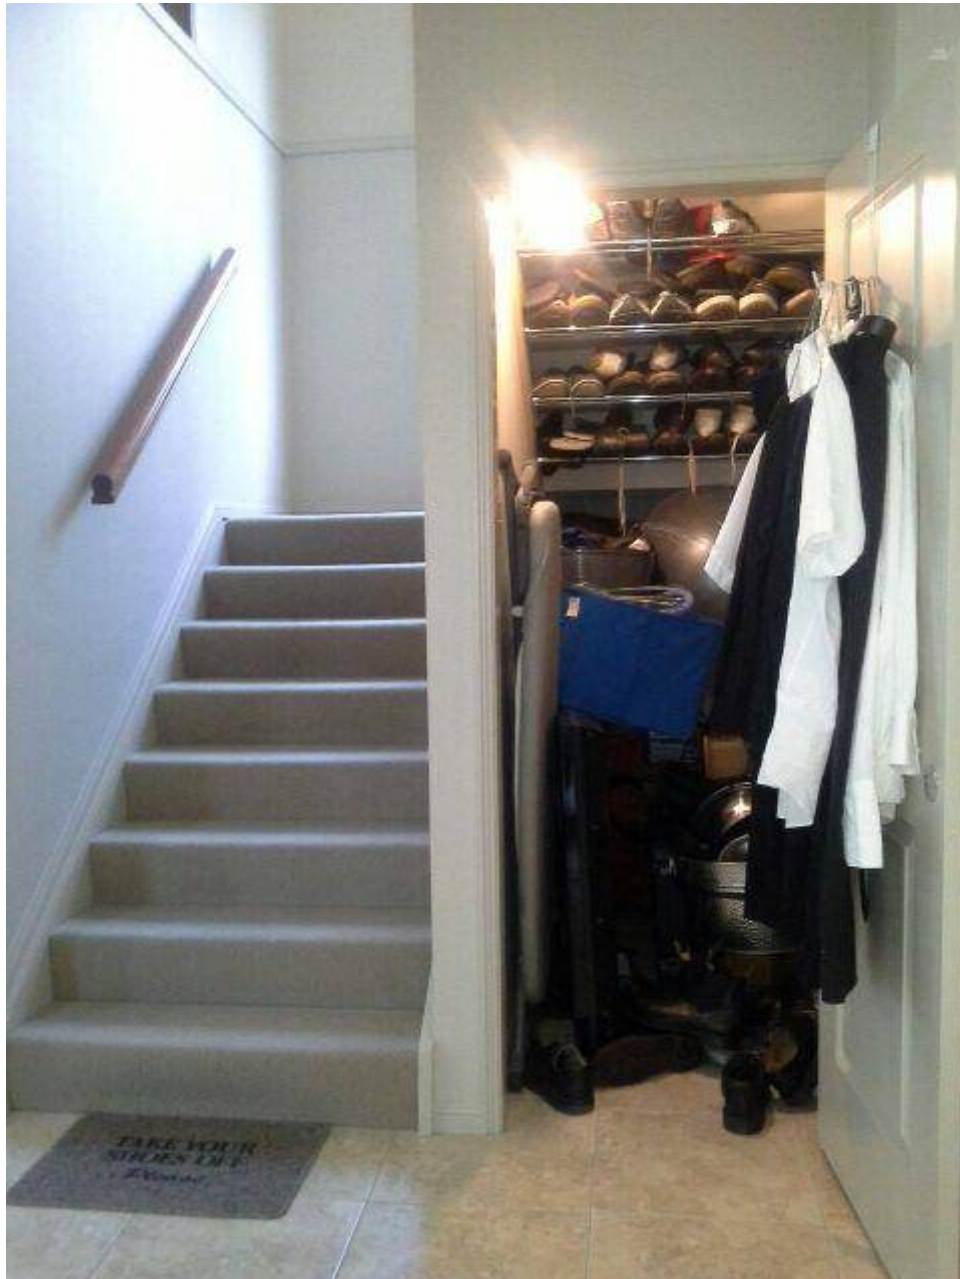
The stairs are constructed primarily from timber. Due to the method of construction or other obstructions there was no access or limited access under the stairs. No comment is made regarding any concealed damage or defect where access was limited or prevented. Complete access should be gained.

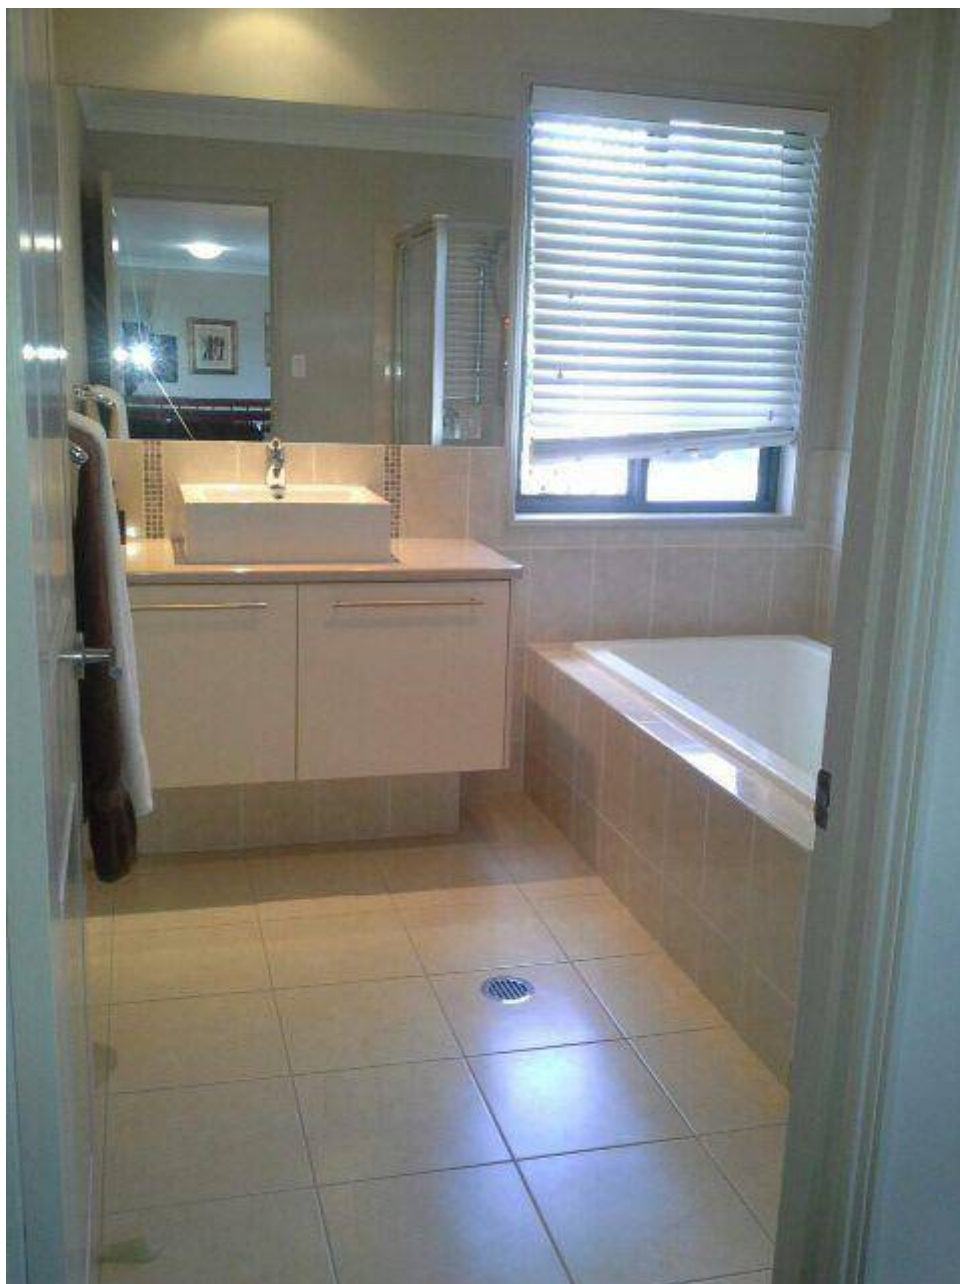
The shower recess does not appear to have been used recently. The lack of recent use could possibly conceal evidence of leakage. While appearing sound, it is recommended that further testing be undertaken to determine the current condition of the shower.

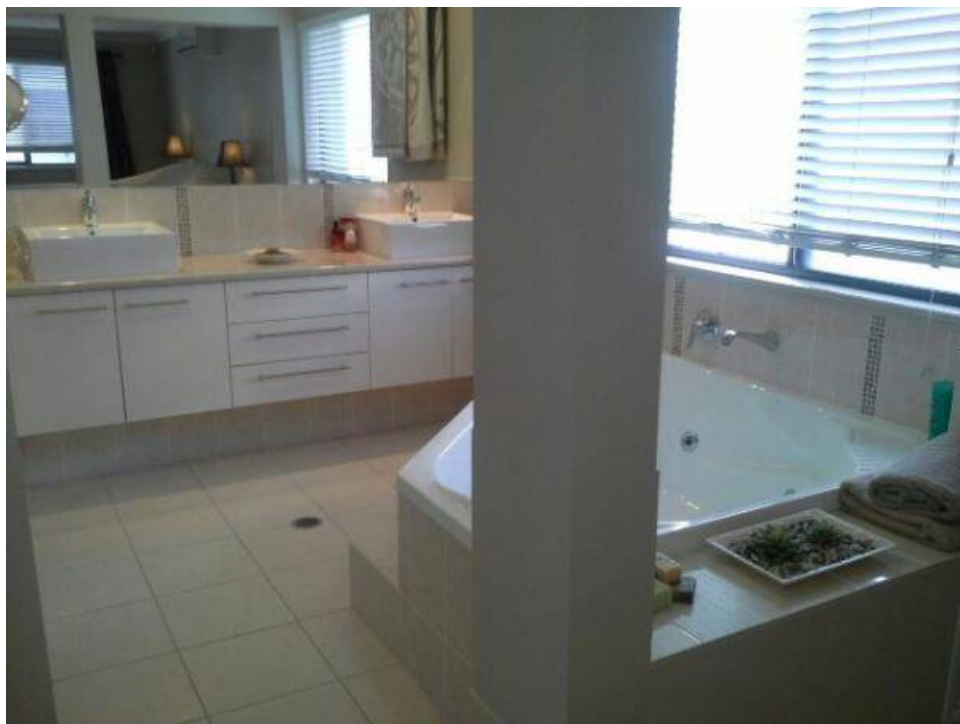
A spa bath is present however, this area was not tested due to the requirement to fill the unit above the water jet level for testing. Defects may be present and not detected.

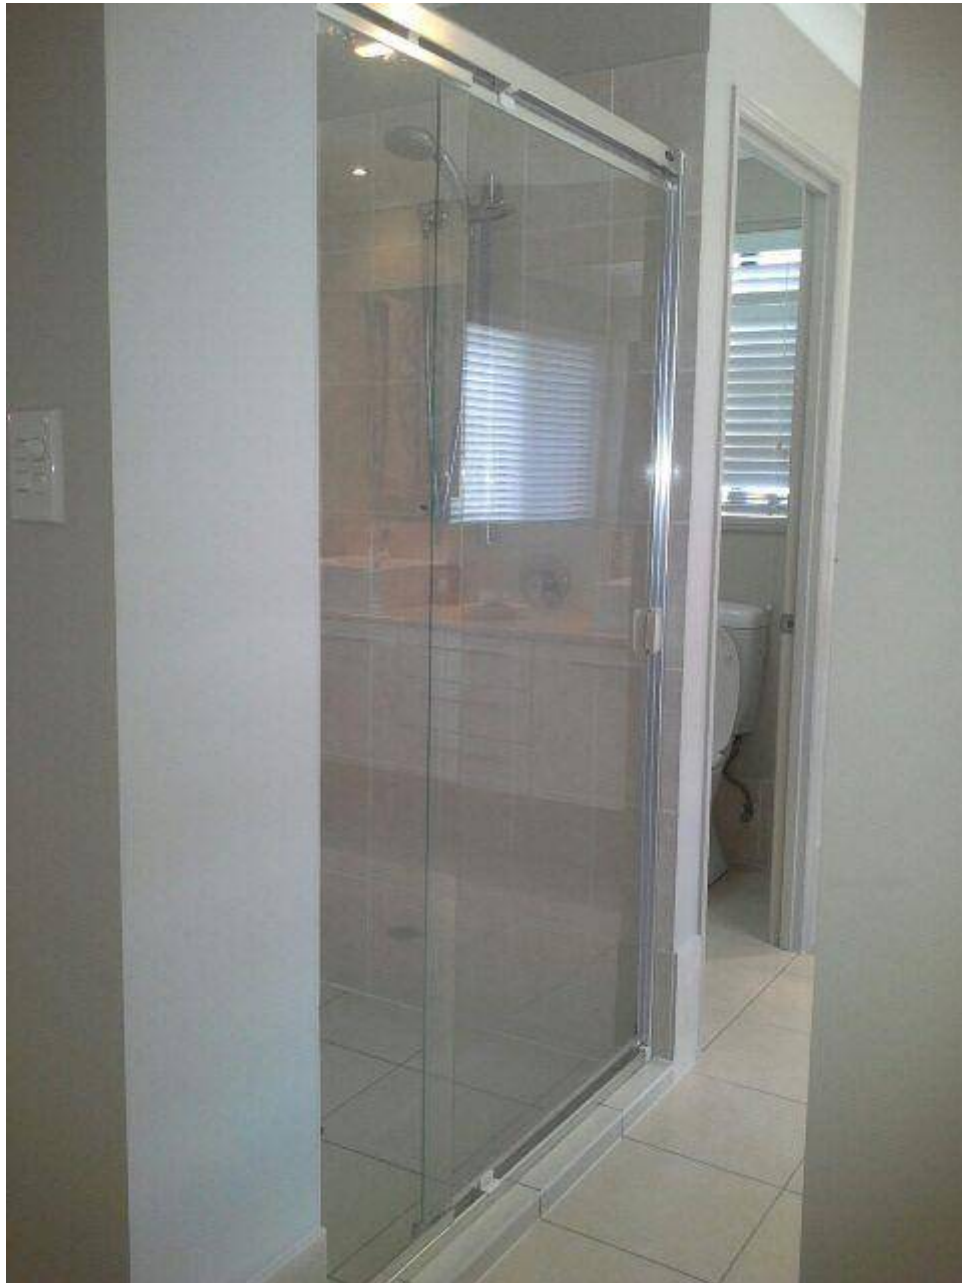
The shower recess was tested and there was no visible water penetration to surrounding areas. **IMPORTANT NOTE:** This test may not reveal water leaks until the shower is put into constant use and surrounding areas monitored over a period of time.

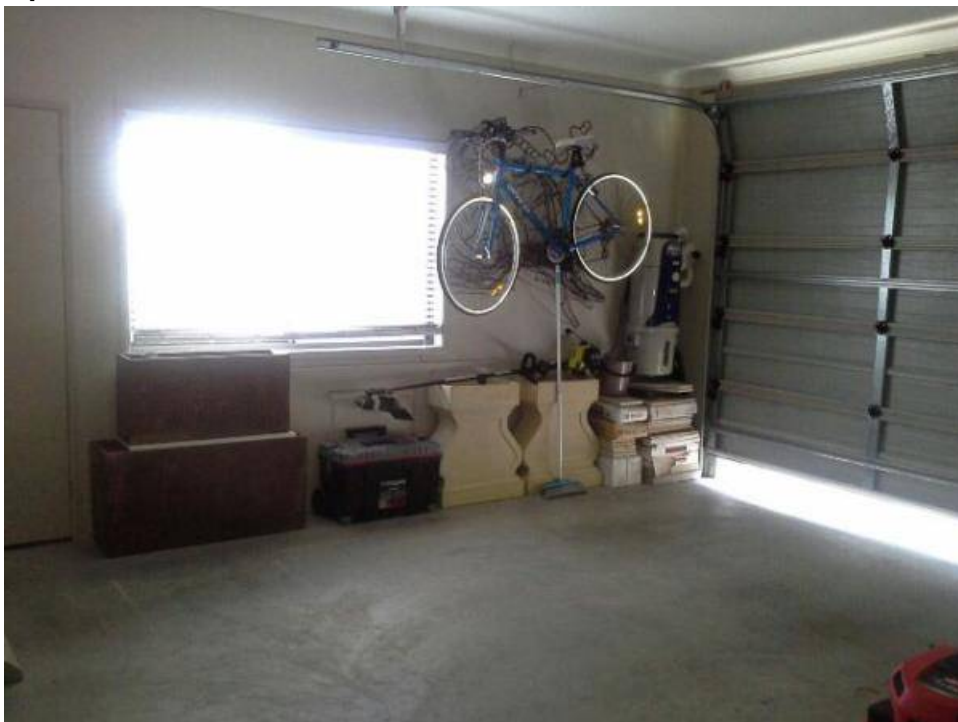
Stored items restricted inspection to the interior. Stored items should be removed to enable a more complete report to be submitted.

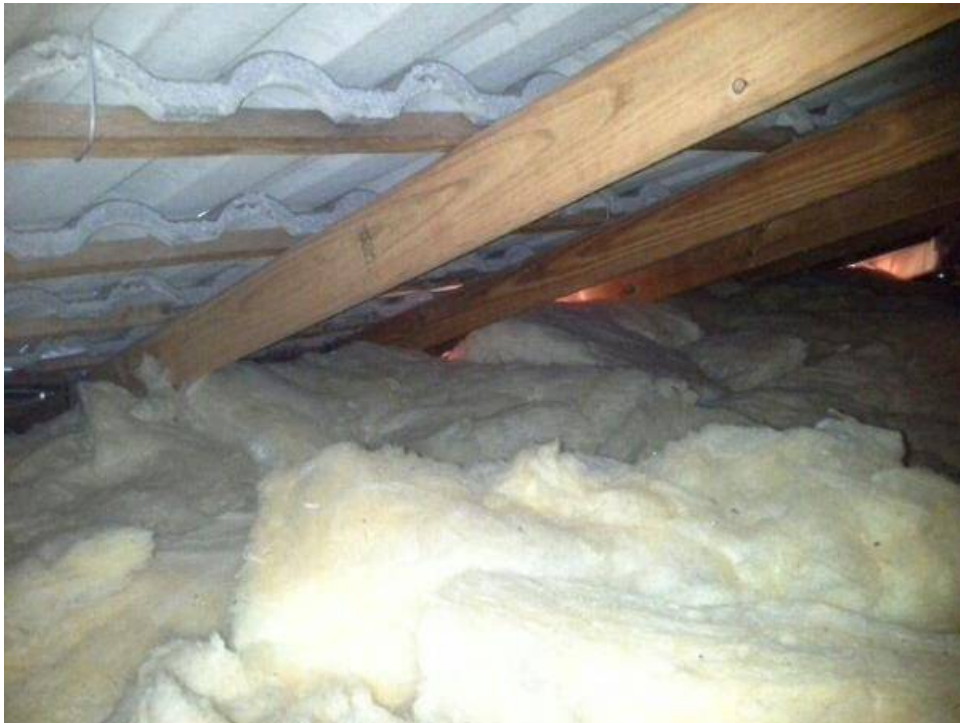
Inspection over the eaves was restricted due to the low pitch and construction allowing only a limited visual inspection. Defects or damage may be present and not detected in areas where inspection was limited, obstructed or access was not gained.

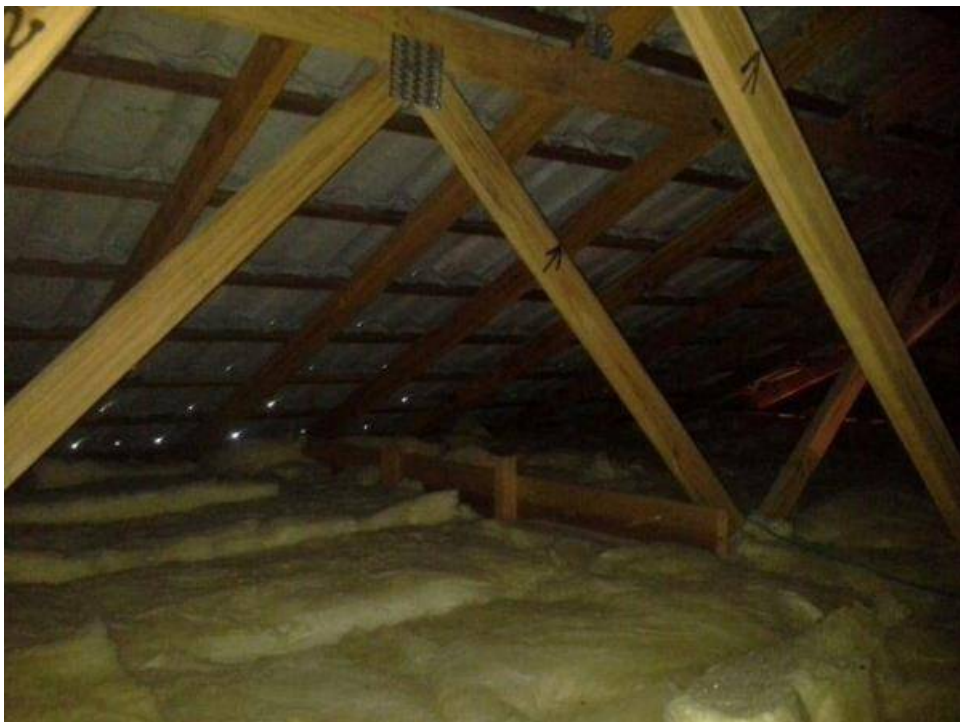
Insulation is present in the roof cavity. This restricted inspection to some roofing timbers. Removal of insulation is not within the scope of a standard visual inspection report. Defects or damage may be present and not detected in areas where inspection was limited, obstructed or access was not gained.

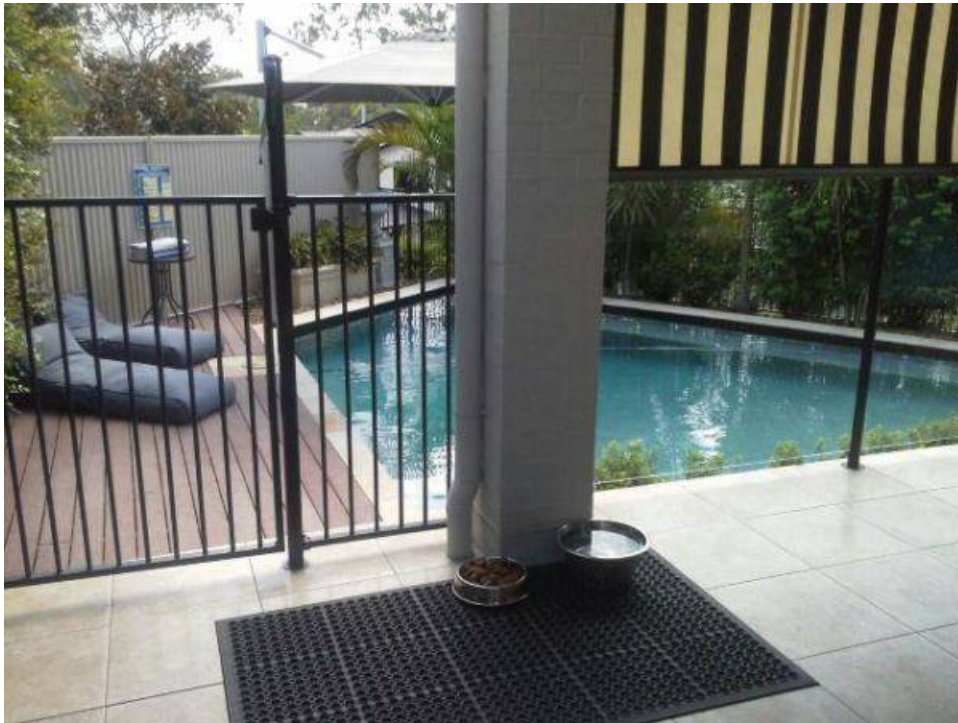
A swimming pool is present. This inspection specifically excludes any inspection of the pool, associated pool equipment and pool surrounds. An inspection should be made by a specialist pool inspector to determine the condition of the pool, pool equipment and surrounds.

Local Authority, or certifier should be called to make a further evaluation and repairs or rectification as needed.

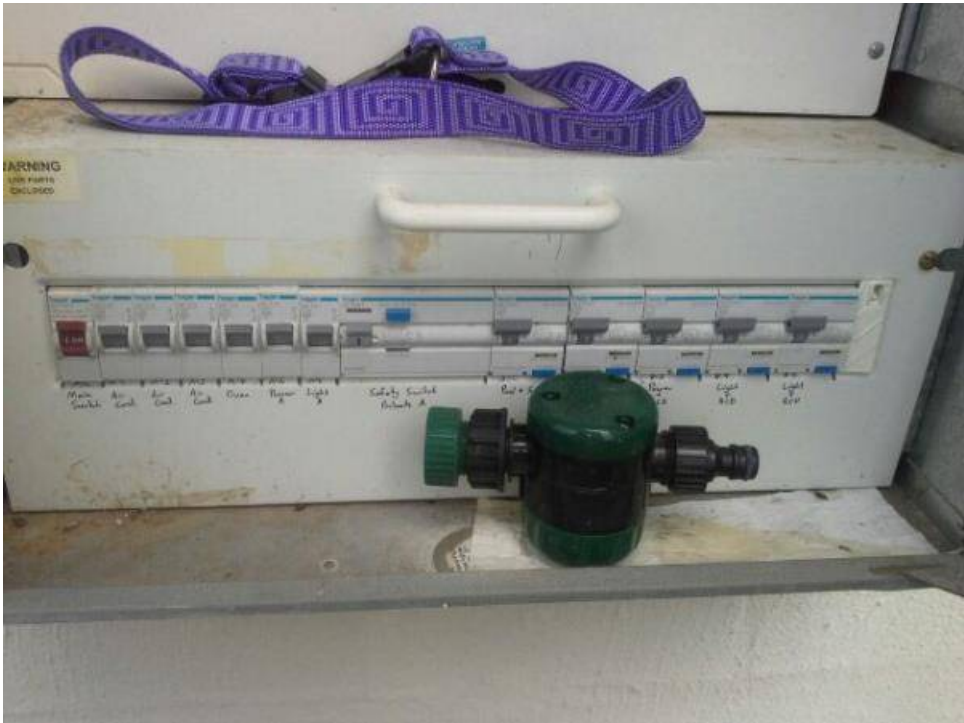
Residual current device (RCD) was noted in the electrical meter box. Functionality has not been tested, please contact a Licensed Electrical Contractor for testing to confirm proper installation and operation.

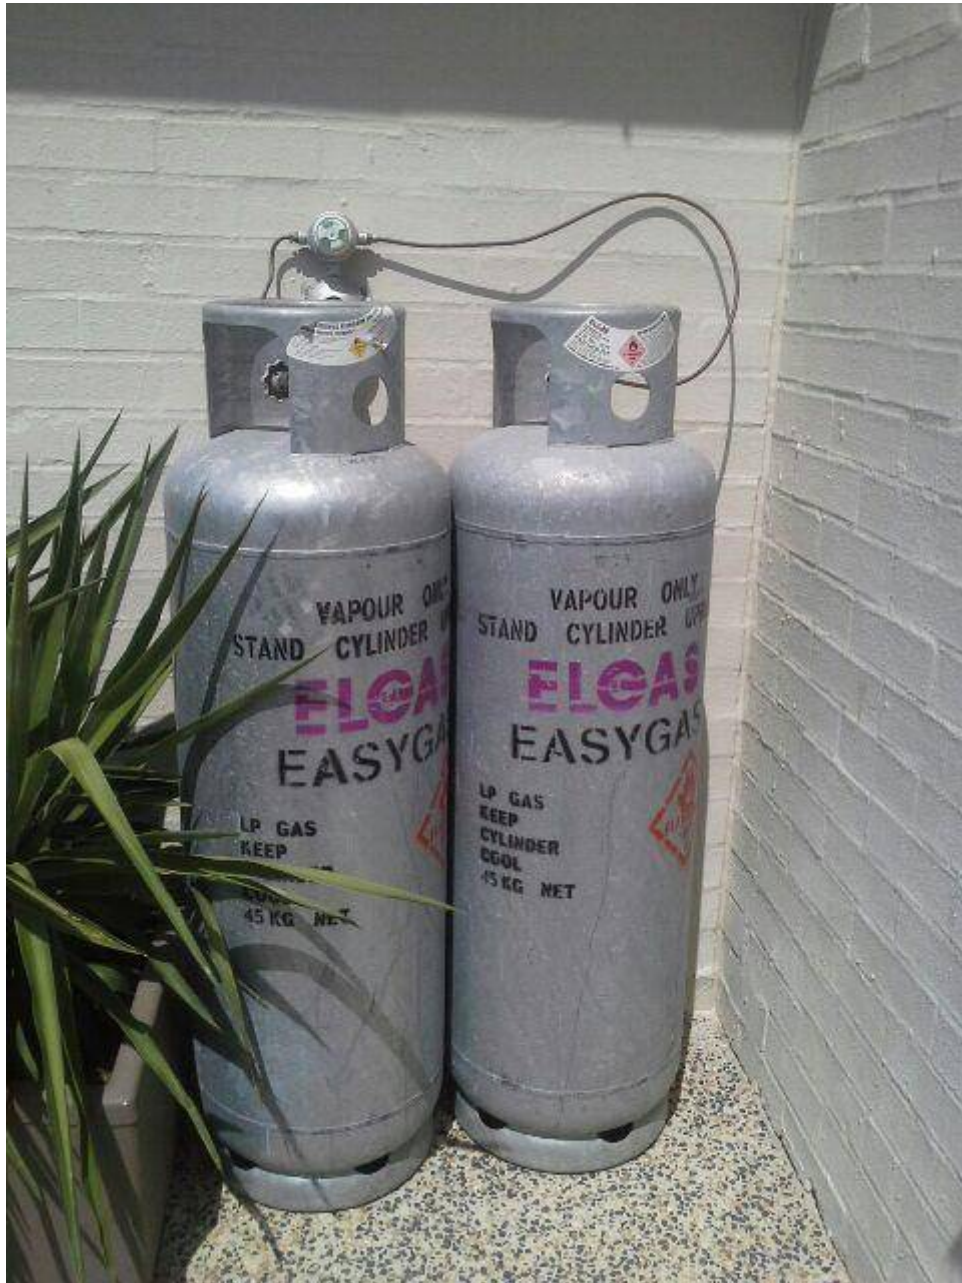
Bottled gas is connected to the premises but has not been inspected. This will require certification or evidence of compliance with the relevant authority.

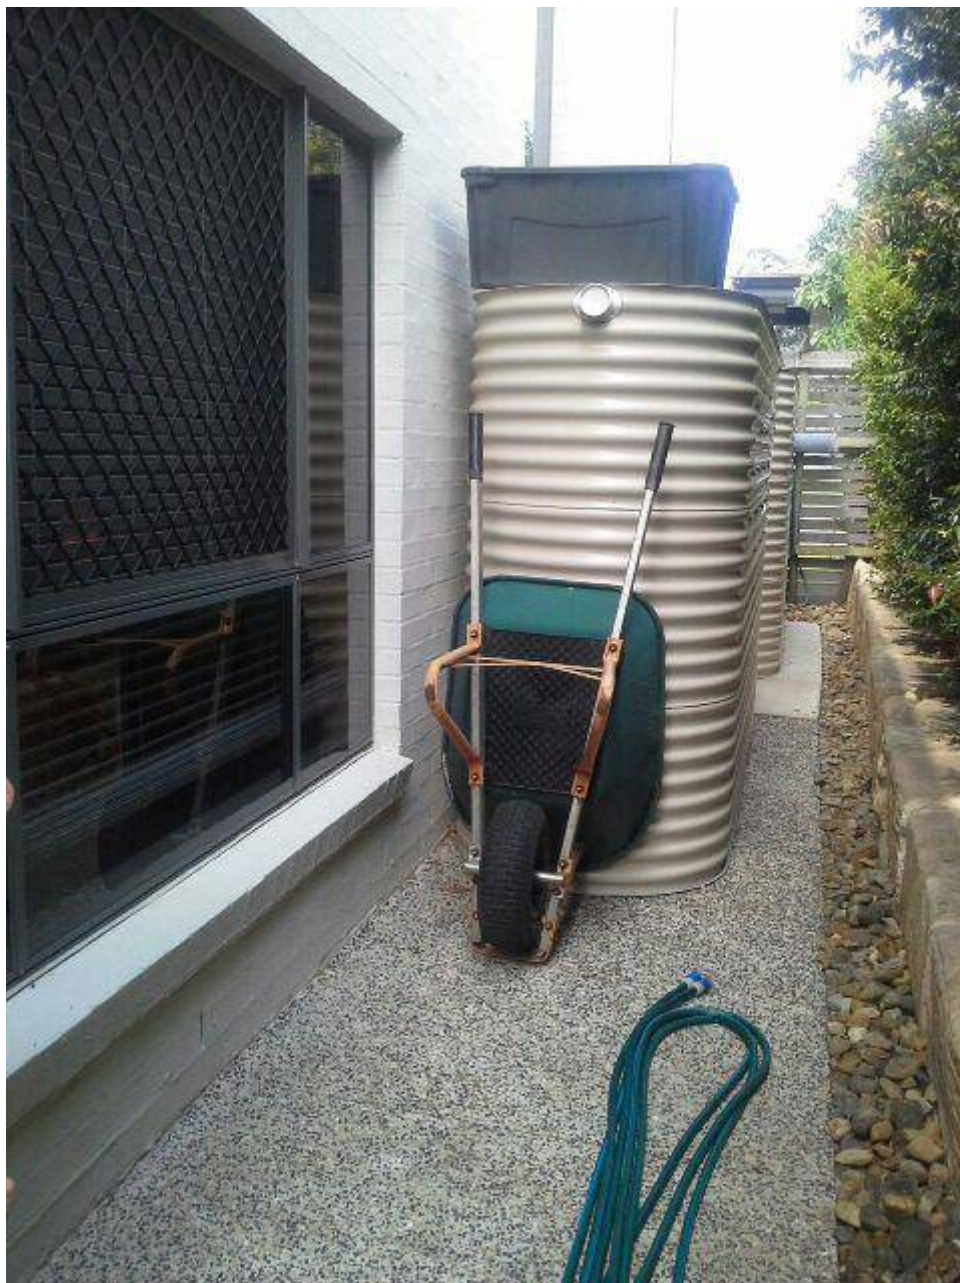
Water Tank prevent access to the wall this should be located atleast one metre away from the wall to allow for unrestricted inspection of the base of the wall. Pavers or concrete paths directly against external wall is restricting visual inspection of the base of the wall. A/C Unit prevents access to the wall this should be located atleast one metre away from the wall to allow for unrestricted inspection of the base of the wall or supporting slab should be poured in conjunction with main slab to prevent areas where termites may be able to gain access without detection.

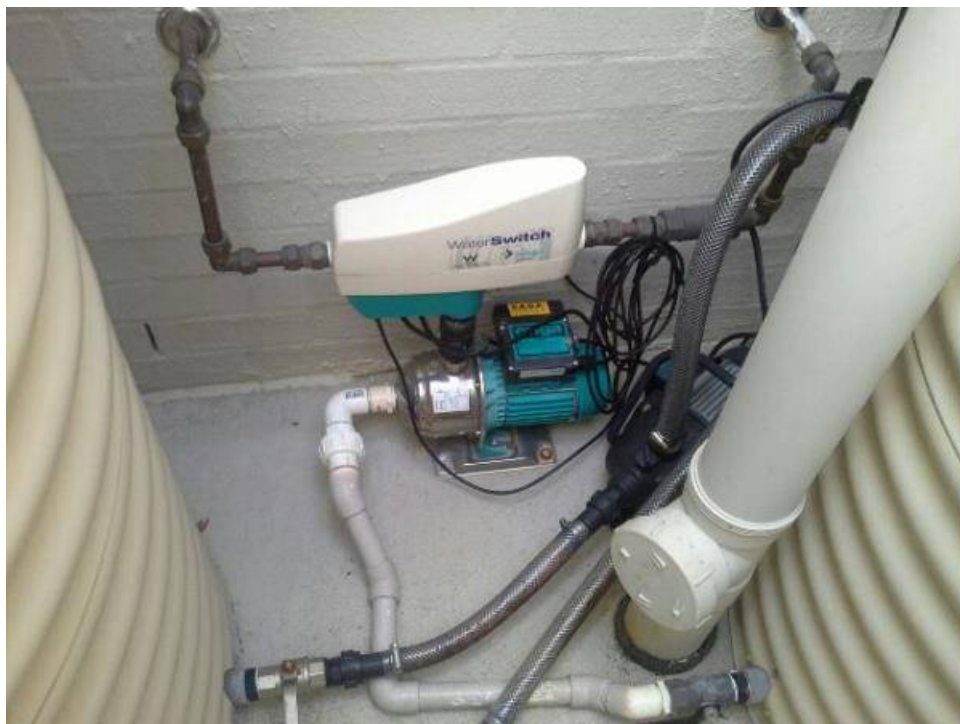
The tank pumping equipment is located directly adjacent to the external wall. This can increase the risk of termite attack as most pool pumping equipment leak some water over time. These moist conditions can be highly attractive to termite attack and the area should be carefully monitored.

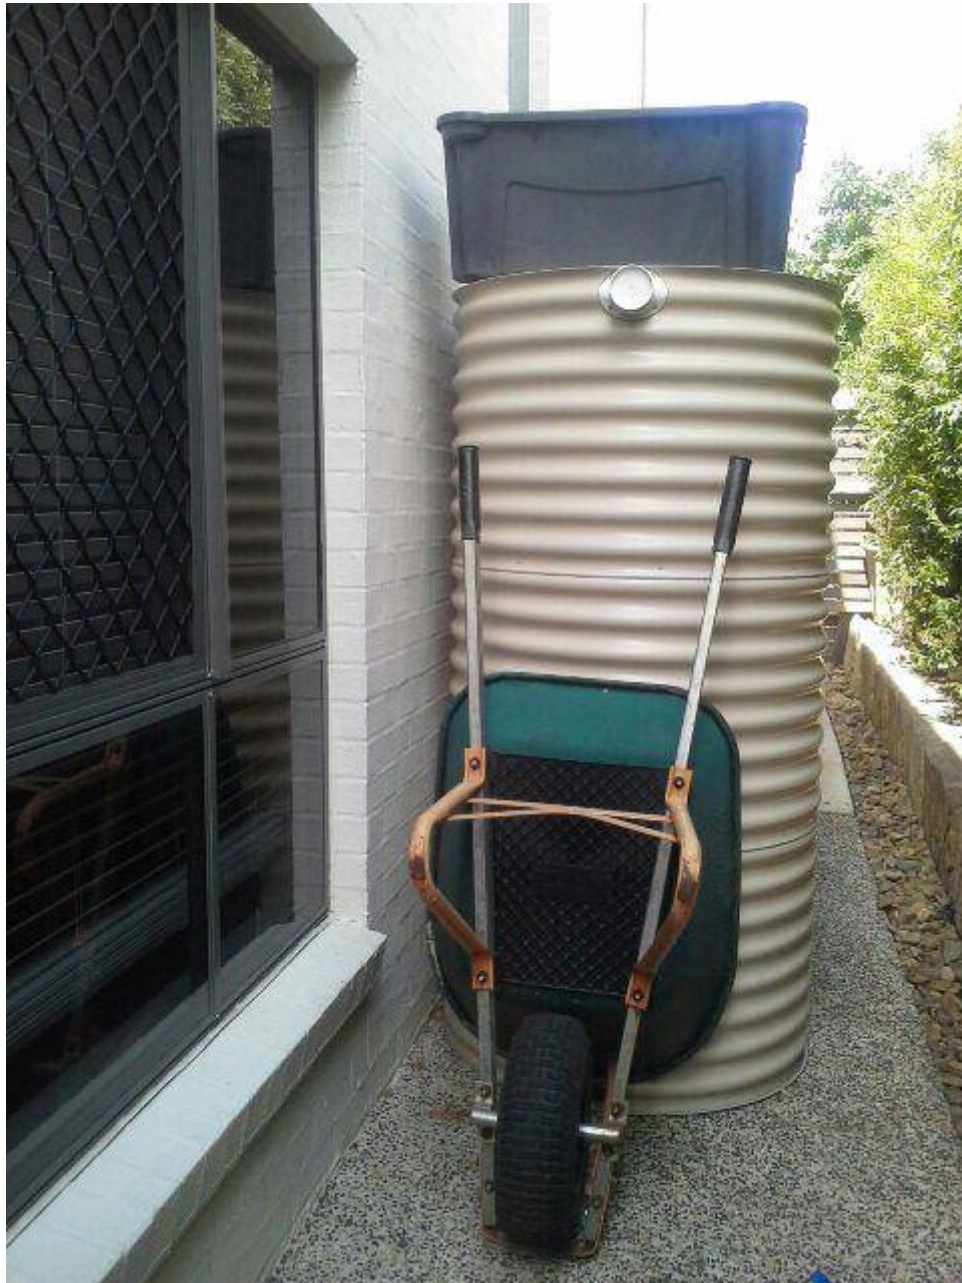
Water Tank prevent access to the wall this should be located atleast one metre away from the wall to allow for unrestricted inspection of the base of the wall.

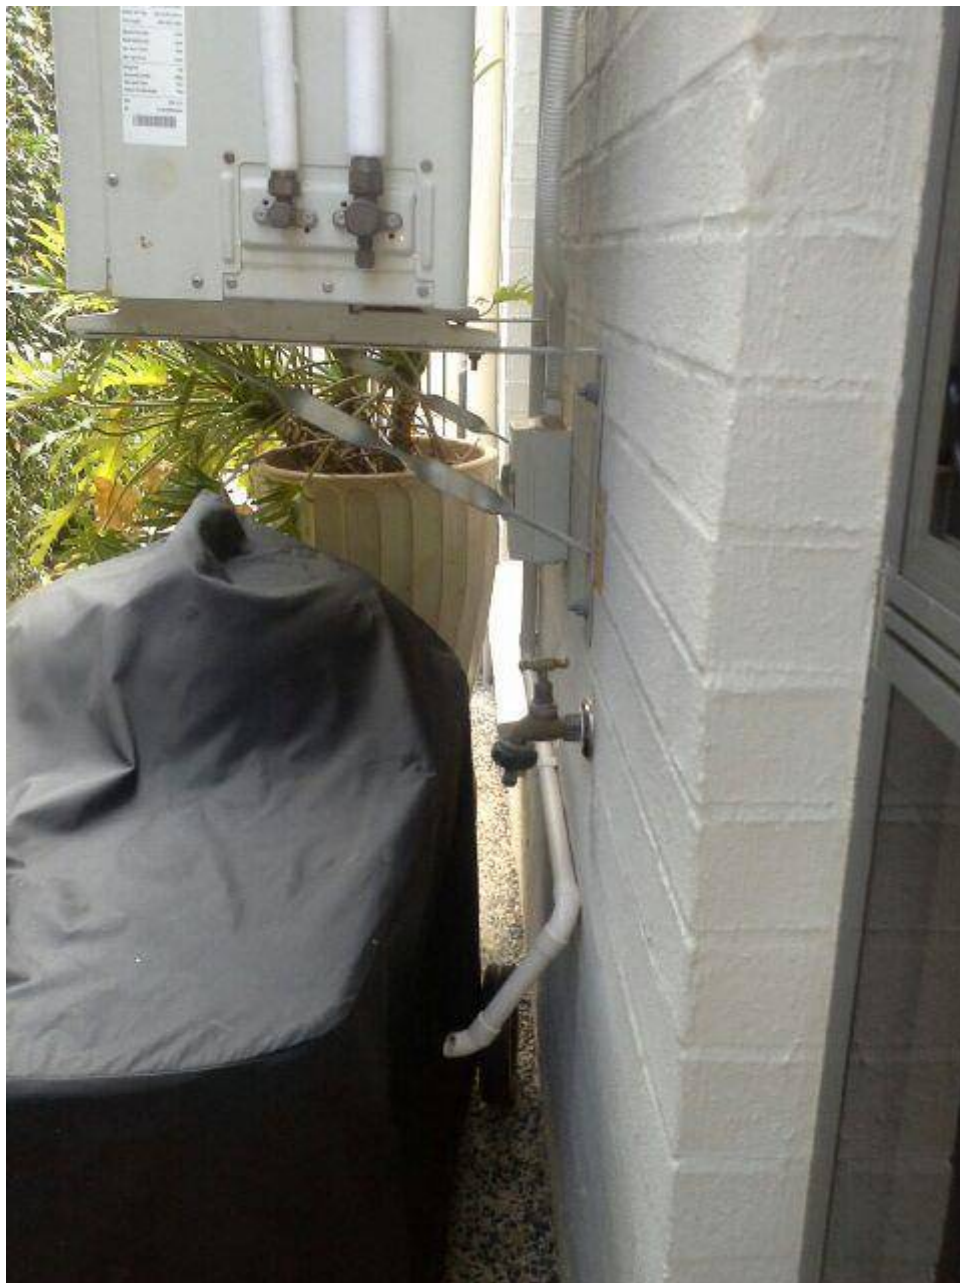
The air-conditioning condenser discharges adjacent to the external walls. We recommend modification so that water is discharged over a drain. Air conditioning units which release water alongside or near to building walls should be piped to a drain (if not possible then several meters away from the building) as the resulting wet area is highly conducive to termites.

Decking timbers are in contact with soil. These should be modified to reduce the risk of concealed termite entry.

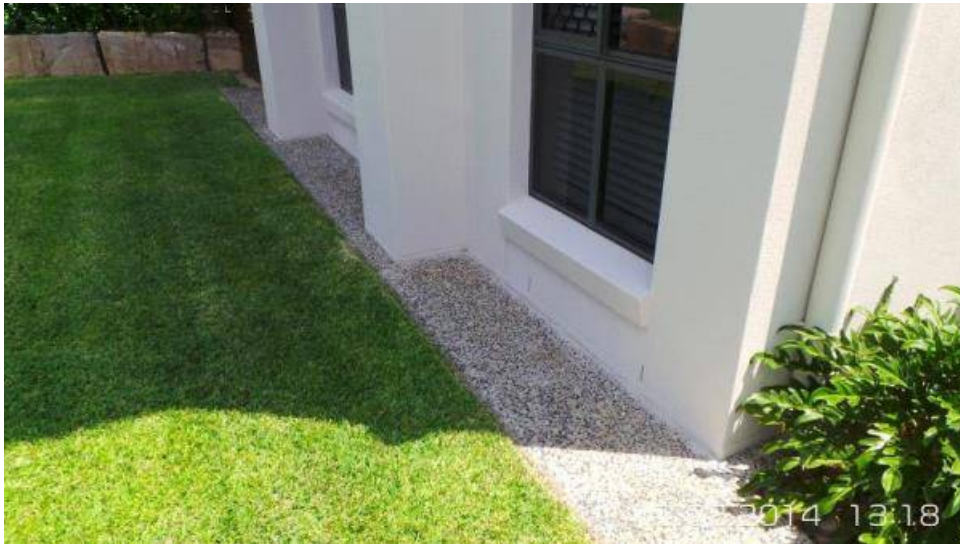
The level of some external paths, paved areas or soil is either higher than, or at a similar level, as that of the internal floors or footing lines where external brickwork is placed, it is our experience that most termite entry occurs between physical termite barriers, finished ground levels and top of footings. This situation could allow concealed termite entry. We strongly recommend if possible the lowering of these to below the internal floor level to reduce the risk of concealed termite entry alternatively an approved proprietary in ground chemical pest barrier should be installed and maintained on a regular basis.

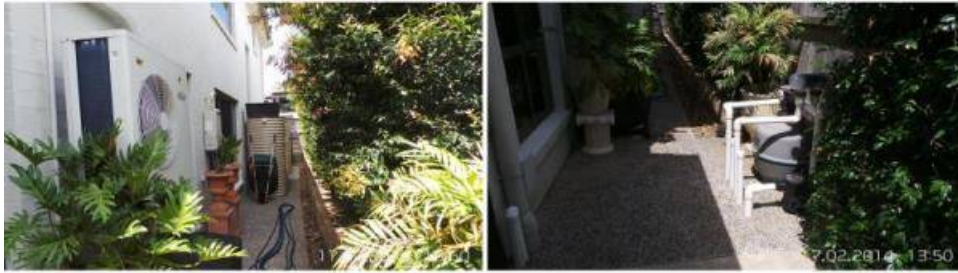
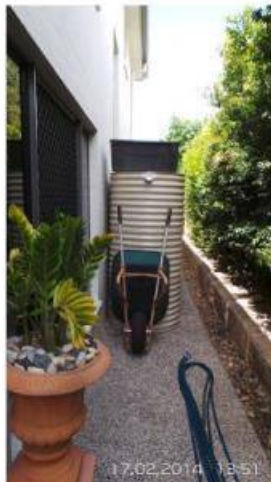
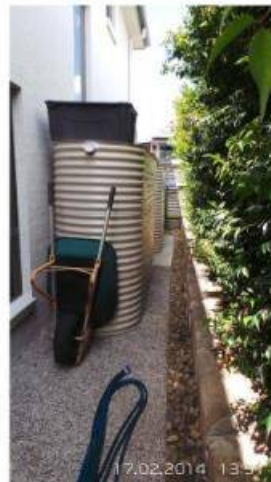
Inspection to the following fencing timbers was restricted in part by foliage - Various fencing timbers:

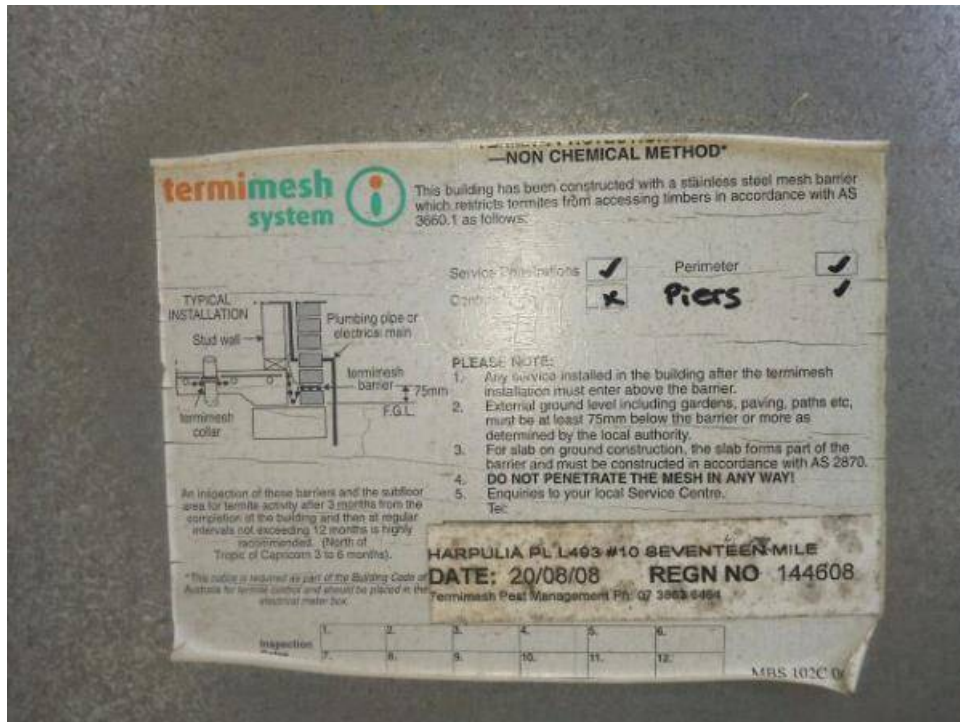
A notice indicates that the property may have been treated during construction in respect to protection against subterranean termite attack. We strongly recommend any prospective purchaser attempt to verify this information and obtain copies of all relevant documentation.
