0813 Example Report 4 bldpst

# **VISUAL BUILDING and PEST INSPECTION REPORT**

## **Building and Pest**

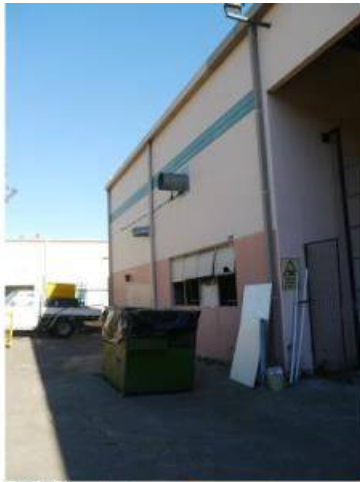
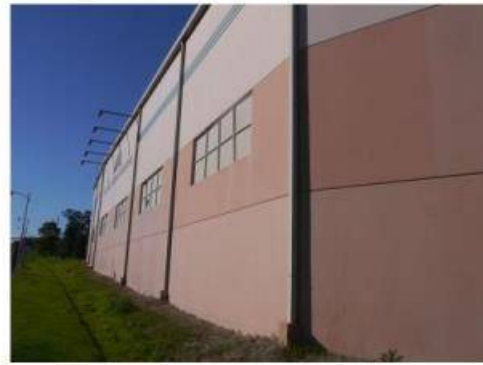
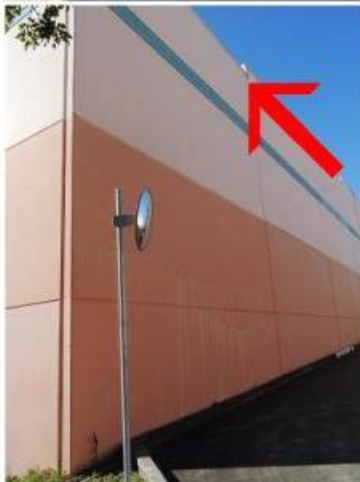
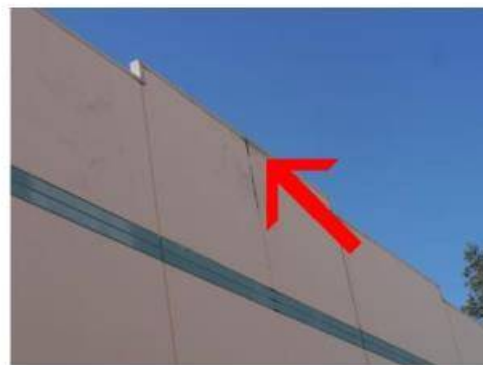
The roof flashings are not visible and therefore no comment regarding roof flashings is made. There may be defects to the flashing materials that cannot be determined, and may only become evident later.

Capping's to wall parapets appear to be in fair condition however capping's and flashings to the roof main area can not be viewed as there is no access to the roof areas. Access to the roof via a cherry picker should be arranged for a more complete inspection as there appears to be obvious damage the roof sheeting and or capping's.

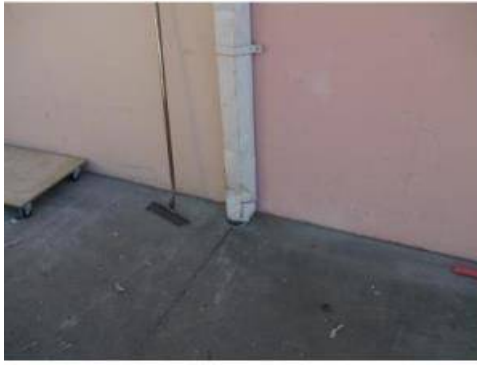
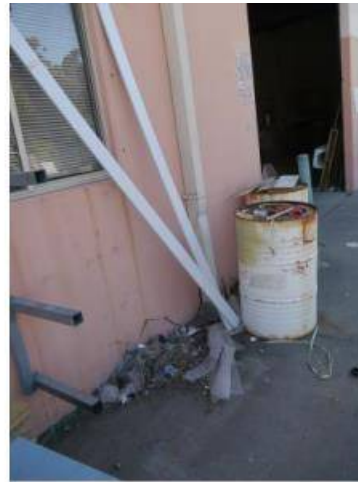
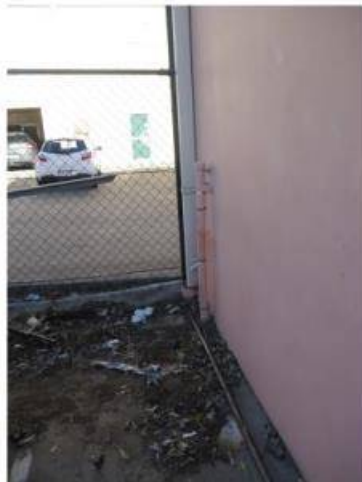
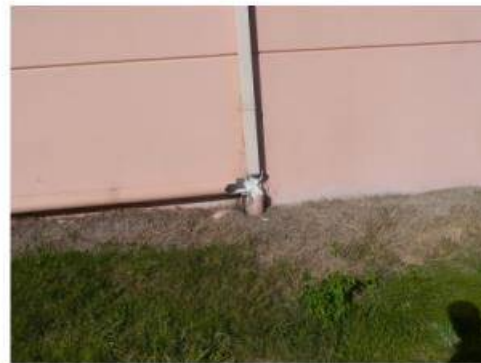
The downpipes are damaged and should be repaired or replaced as necessary. Gutters used are not what is typically used in current construction and if changes are required complete replacement may be necessary.

A licensed plumber should be called to make a further evaluation and repairs or rectification as needed.

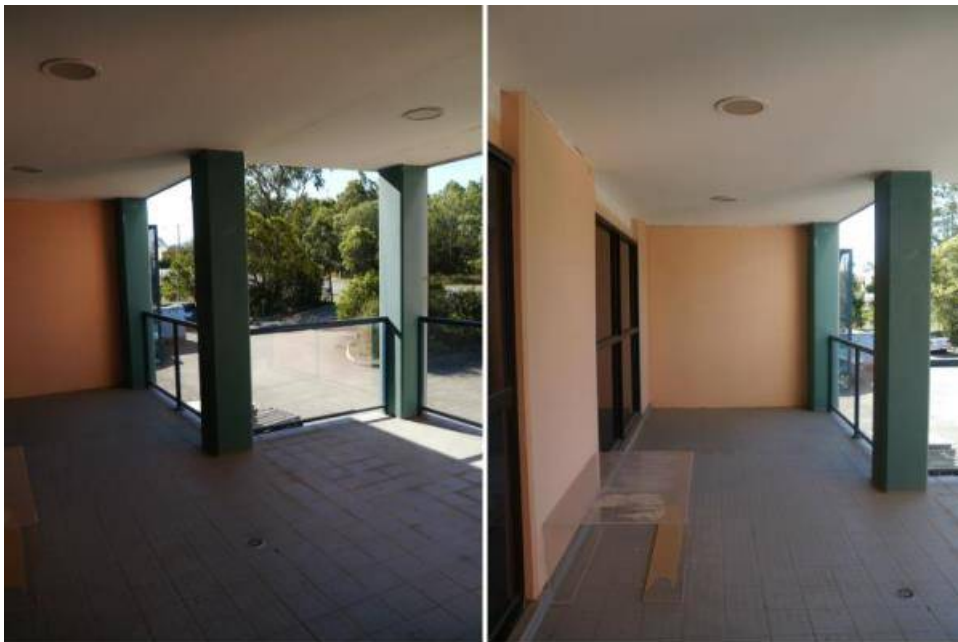
The overall condition of the eaves lining is poor. The paint work to the eaves is deteriorating and maintenance is required. Water damage/staining is present to the eaves linings which may be due to condensation, damaged sarking (if present) or leaking roof tiles/roof flashings and or valleys, gutters and downpipes that may have leaks or have been compromised with debris from vegetation. This should be further evaluated by a roofing contractor. Some eaves linings are sagging and require re fixing or replacement.

A licensed builder should be called to make a further evaluation and repairs or rectification as needed.

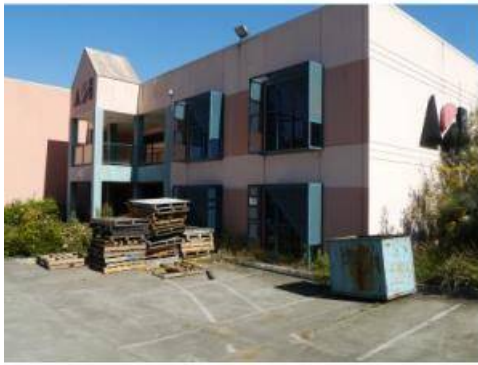
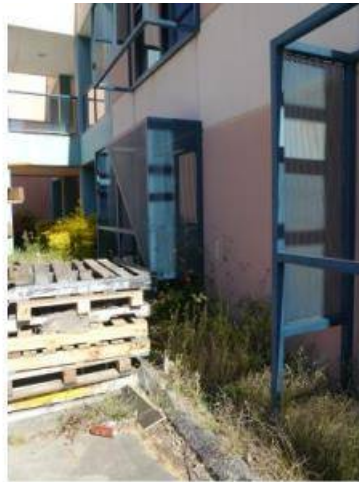
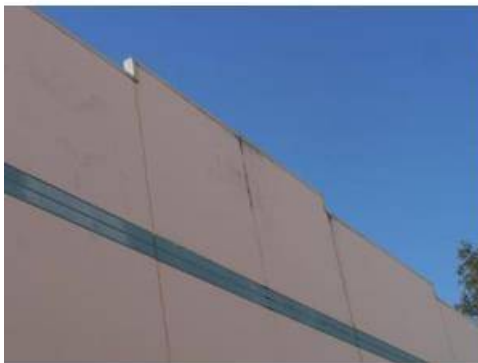
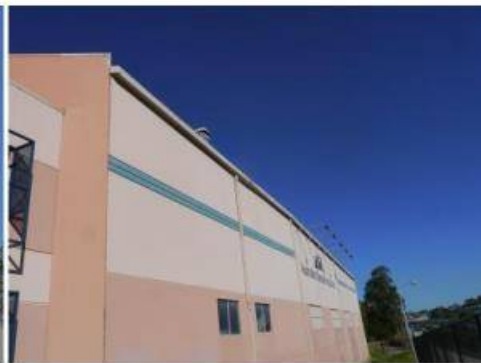
The condition of the walls is generally fair. Paint deterioration was present to external surfaces. Maintenance and/or repairs will be required.

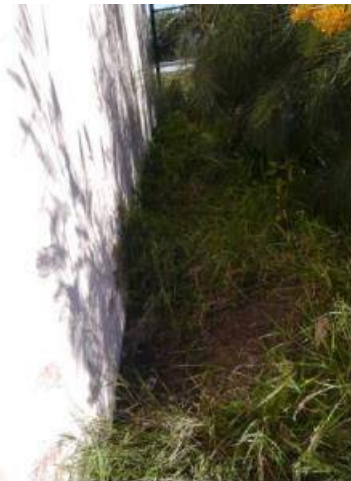
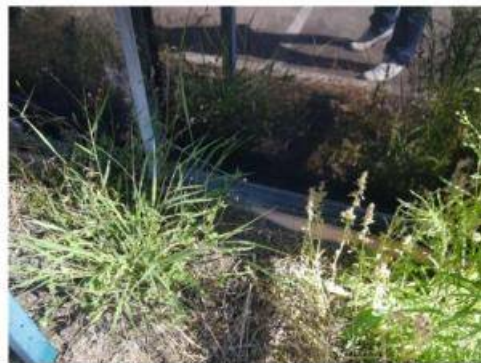
The base of some walls are below the external soil levels and may be subject to lateral dampness or water entry. Recommend soil levels be lowered or the area be closely monitored for water entry/penetration.

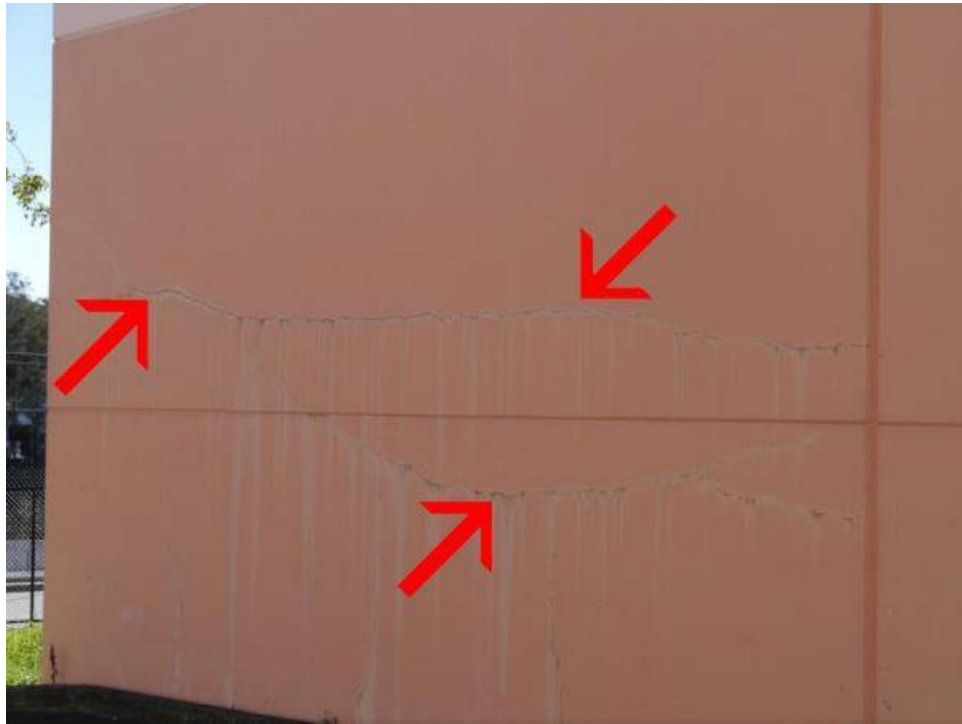
There are cracks within the precast panels on the rear left hand side of the building which appears to be at or around the internal slab level, it is obvious that there has been pressure applied by the floor slab or subsoil that is being retained by the precast panel, it is not clear whether the pressure is current or due to construction processes, or how long the damage has been there it may have been as a result of initial compaction of the soil below the internal slab during the construction phase.

We recommend an engineer be engaged to comment upon and offer further advise regarding the above issue.

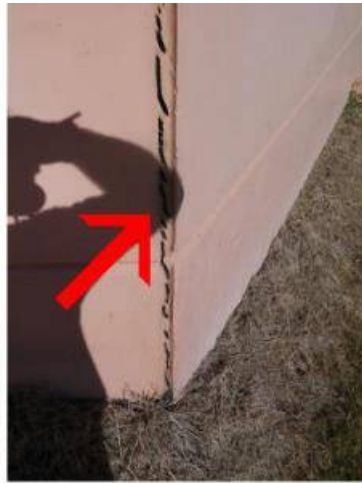
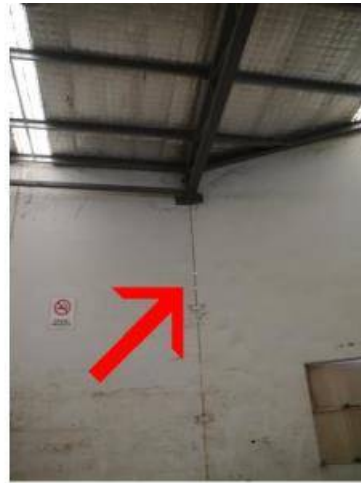
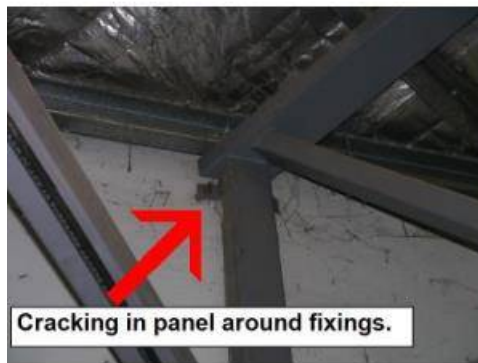
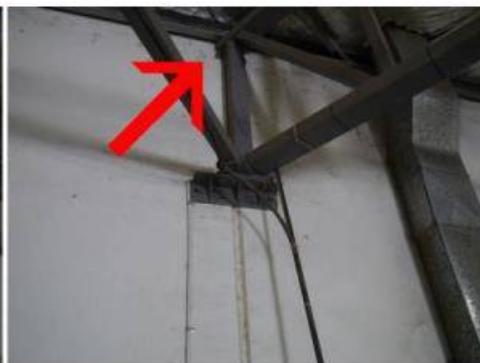
Some sections of the wall panels have evidence movement which will require further monitoring to establish whether remedial works are required to prevent further movement and damage.

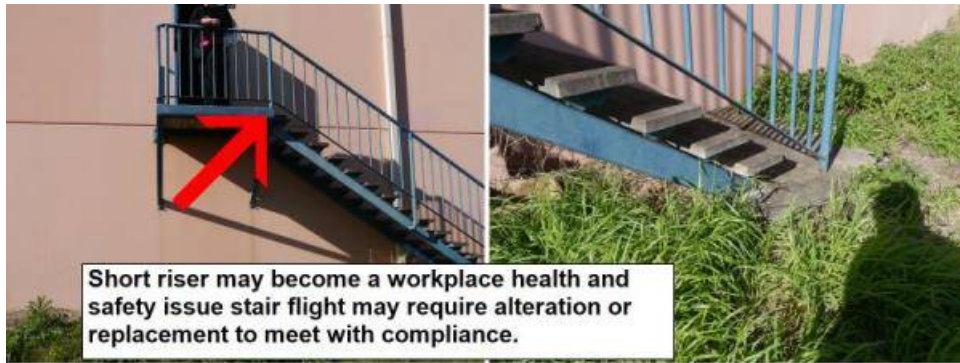
Stair with concrete treads on steel stringers are in fair condition however the rises are inconsistent and may present a trip hazard, these stairs clearly do not comply with the NCC and BCA.

A licensed builder should be called to make a further evaluation and repairs or rectification as needed. Local Authority, or certifier should be called to make a further evaluation and repairs or rectification as needed.

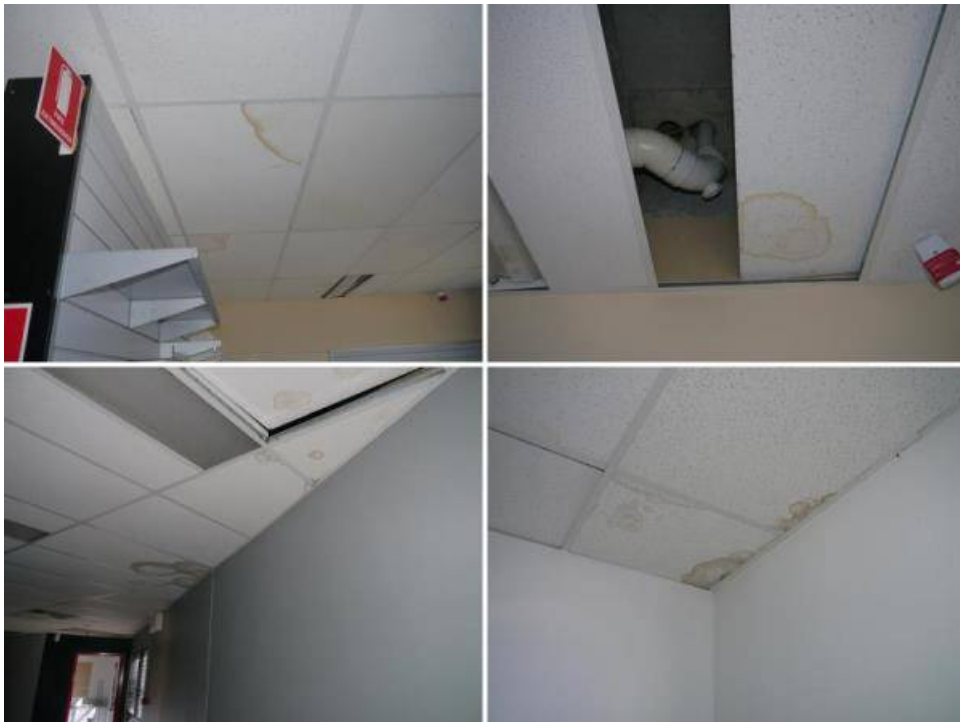
The condition of the ceiling tiles is generally poor, they have water damage throughout many areas some areas appear to be affected by water migrating through roofing sheet other areas appear to be affected by AC condensate drains and ducting.

Defective surfaces were noted and maintenance will be required.

Sagging was noted to the ceiling tiles this sagging is due to moisture damage.

Evidence of past or current water penetration through the ceiling. (We believe the leaks maybe current.)

A licensed roofing contractor should be called to make a further evaluation and repairs or rectification as needed.  
An Air Conditioning contractor should also be engaged to check the entire system for defects as it appears in some circumstances that some leaks maybe due to the air conditioning system.

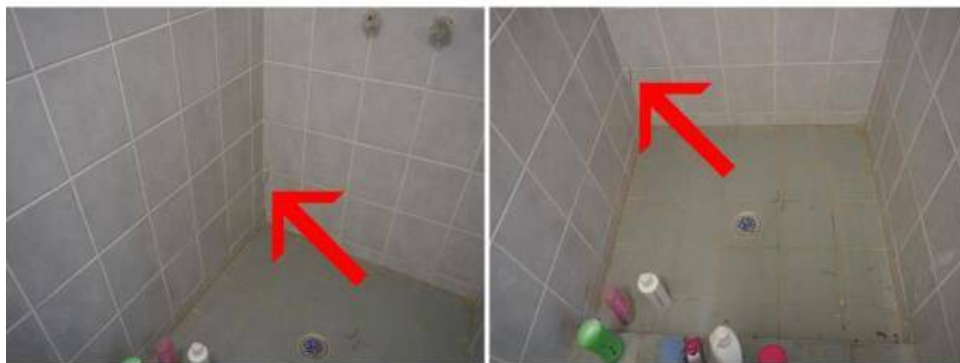
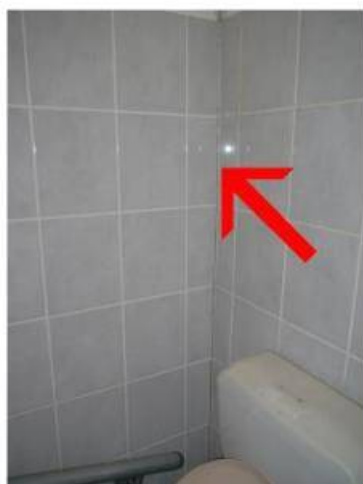
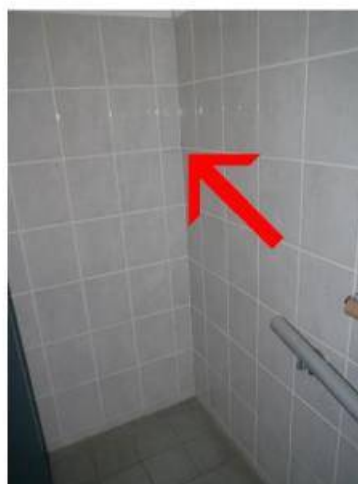
The condition of the plasterboard wall sheet is generally fair. Tiled bathroom walls have damage to tiled surfaces where inadequate expansion joints or the complete failure to provide expansion joints has occurred.

A licensed builder should be called to make a further evaluation and repairs or rectification as needed. We recommend an engineer be engaged to comment upon and offer further advise regarding the above issue.

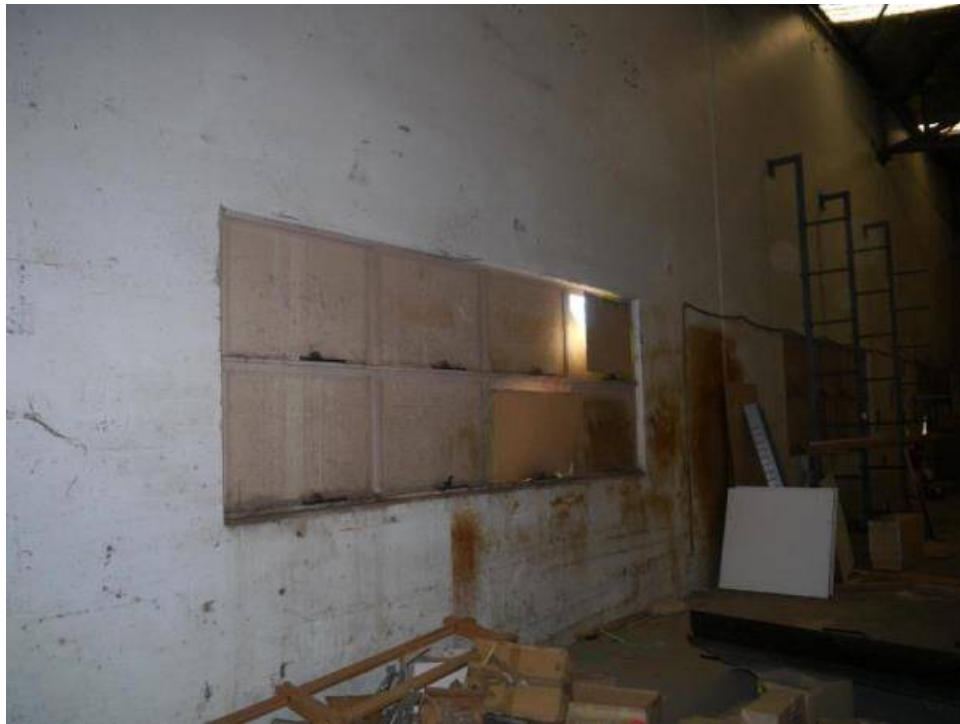
Factory area. Cracked glass was evident and will require replacement.

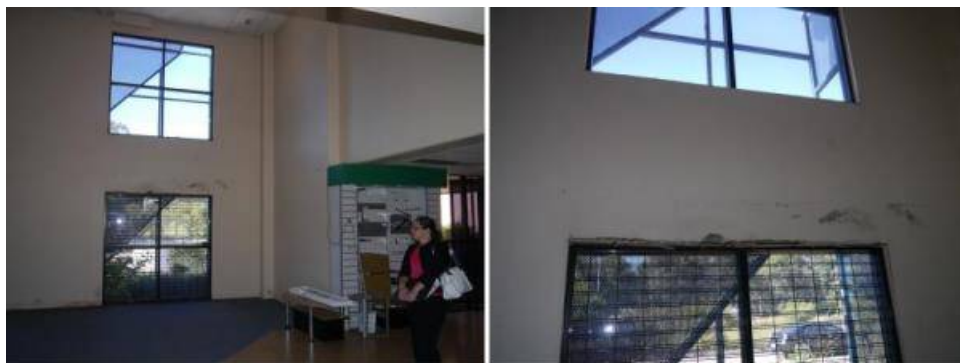
Showroom area: The condition of the window installation is generally poor. Please note a glass audit should be conducted to confirm legal compliance and potential risks.

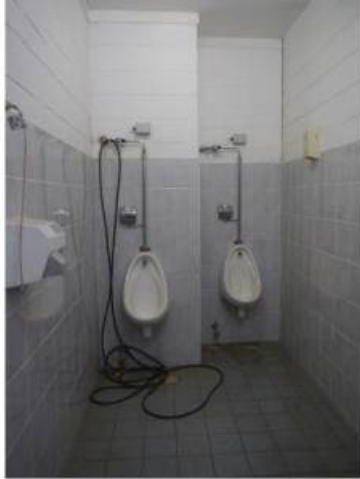
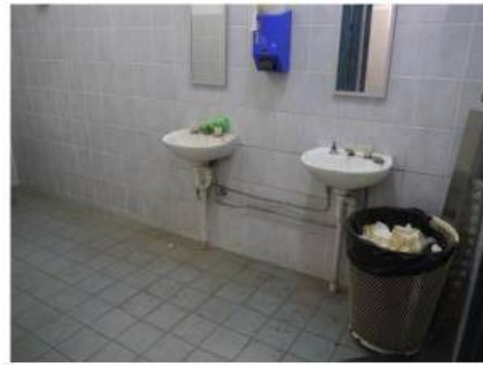
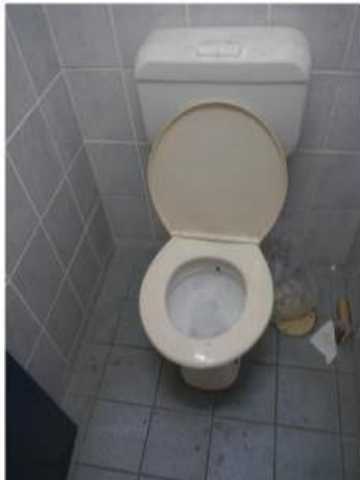
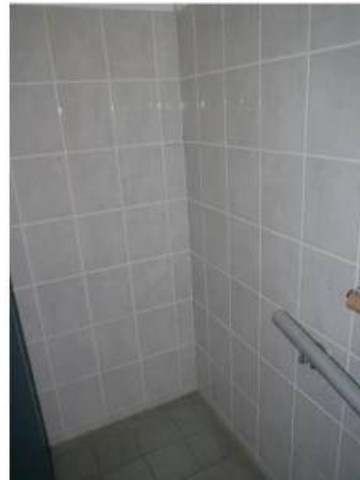
This area is generally in poor condition maintenance will be required.

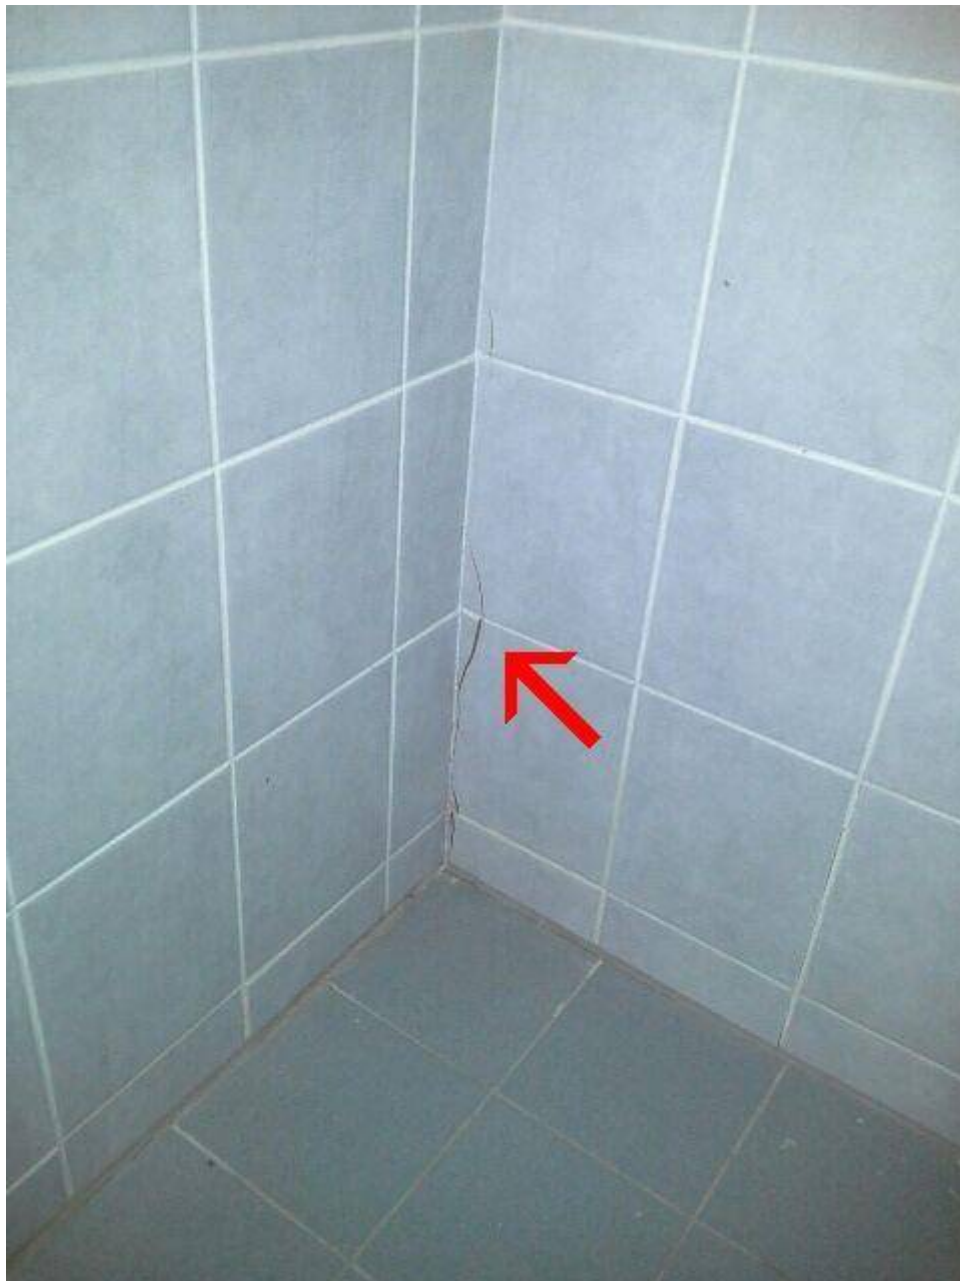
Some cracked tiles were noted in this area. This is considered a cosmetic issue. Rectification may be desired and if necessary, contact a floor and wall tiler for rectification.

The failure to provide effective control joints has contributed significantly to tiles cracking in wet areas. Control joints that comply with current Australian standards should be installed.

A flexible sealant should be provided to the gaps between internal tiles at vertical and horizontal wall and floor joints to allow for expansion and contraction between surfaces preventing damage between tile surfaces controlling and eliminating potential pressure on membranes behind tiles from uncontrolled movement which may lead to membrane damage, also provides an acceptable finish and resist water penetration in areas where free moisture may flow during normal use as in areas such as shower screens, basins and sinks where limited controlled moisture maybe present also in kitchen, laundry and bathroom bench tops and vanities, these joints are not provided to perform as a substitute for water proofing barriers as found in wet areas behind the tiles. These joints as described in standards are to be typically 6mm which is rarely complied with in domestic construction.

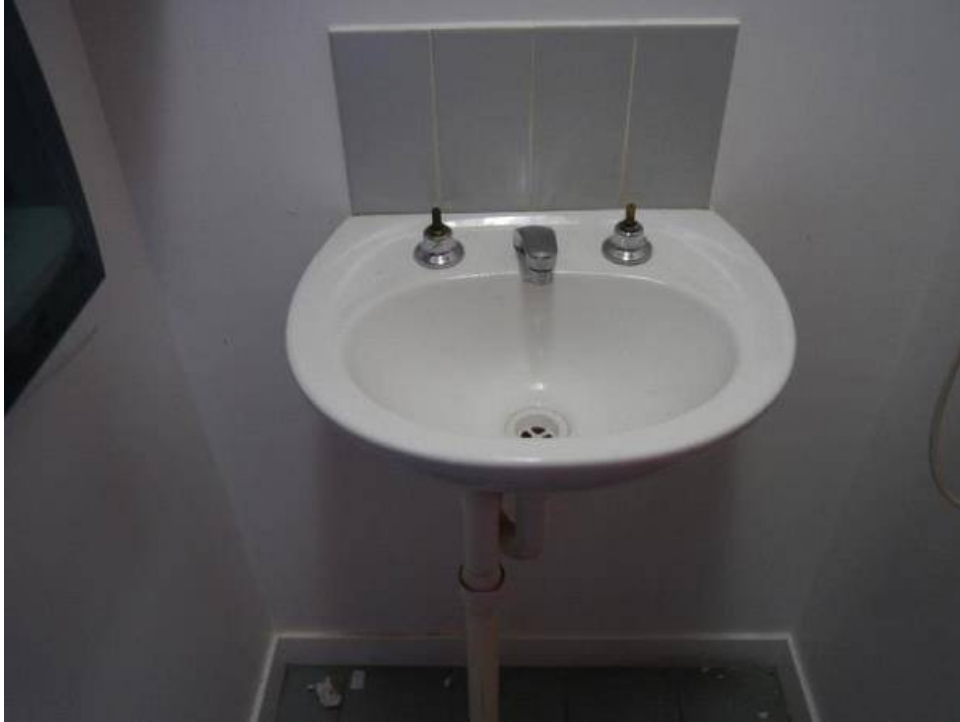
The basin appear serviceable taps may require replacement. Drain not tested.

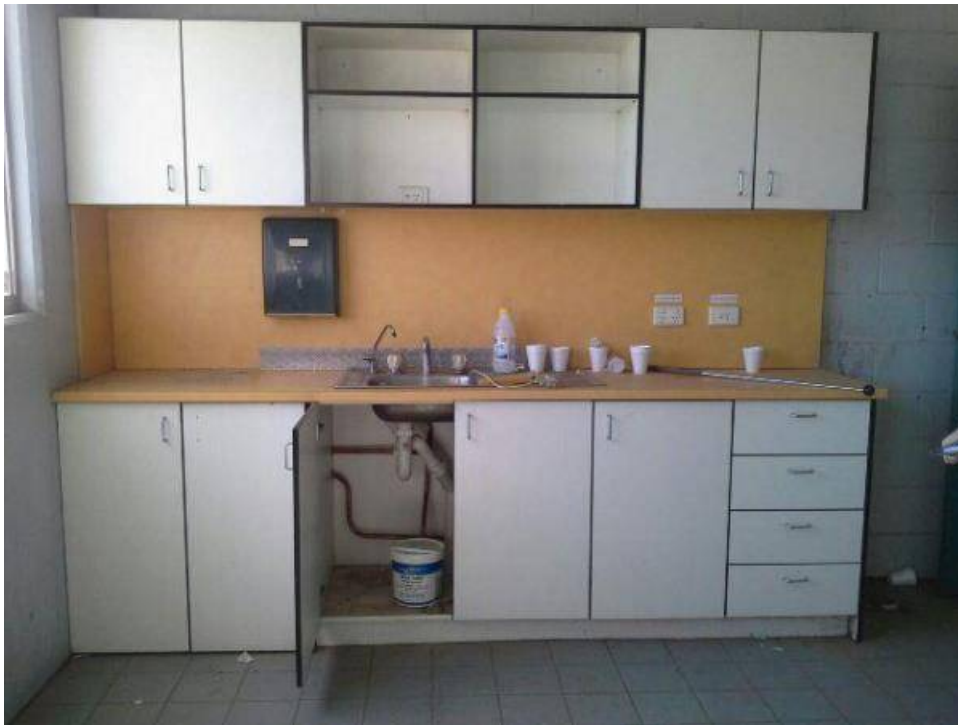
The condition of the fixtures is generally poor.

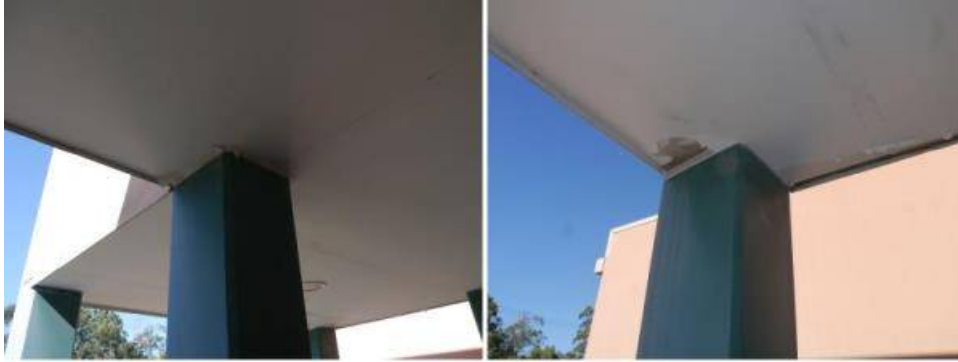
Soffit is in poor condition and may require replacement.

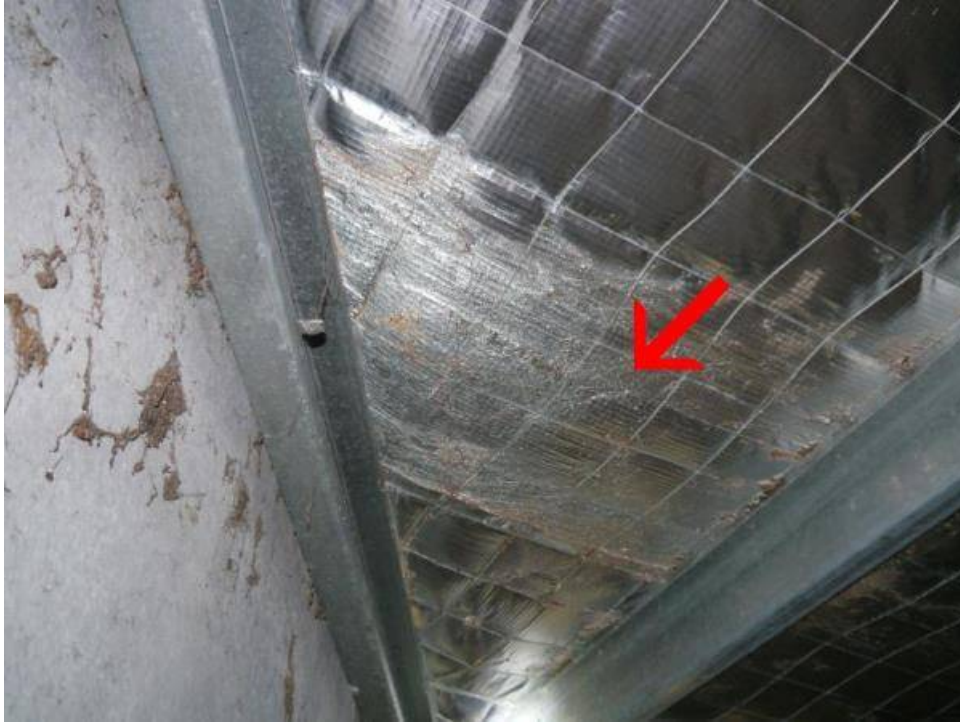
Sarking appears to be in place. Sarking has deteriorated due to what appears to water damage.
