VISUAL BUILDING and PEST INSPECTION REPORT	6
ROOF SYSTEM EXTERNAL	9
EXTERIOR	16
INTERIOR CONDITION REPORT	19
BATHROOMS	25
TOILETS	29
LAUNDRY	35
KITCHEN	37
DECKS, PERGOLAS, BALCONIES, VERANDAHS, AWNINGS	39
GARAGING	41
ROOF SYSTEM INTERNAL	46
FOOTINGS	46
SITE	46
SERVICES	48
Important Information	50
VISUAL TIMBER PEST INSPECTION PART 2 of REPORT	54
BRIEF SUMMARY	56
ROOF	57
INTERIOR	57

Example Qld

1113 Example 5 bldpst

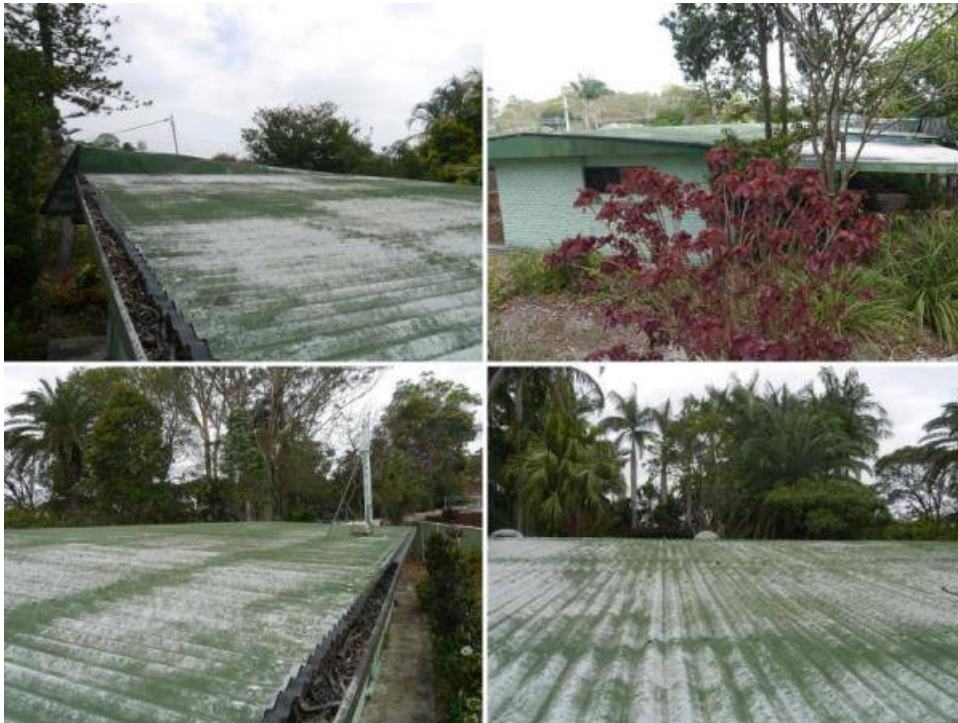
The overall condition of the roof coverings is fair. It should be noted that coverings are only viewed from a distance in some areas and sometimes defects are very small and not clearly visible.

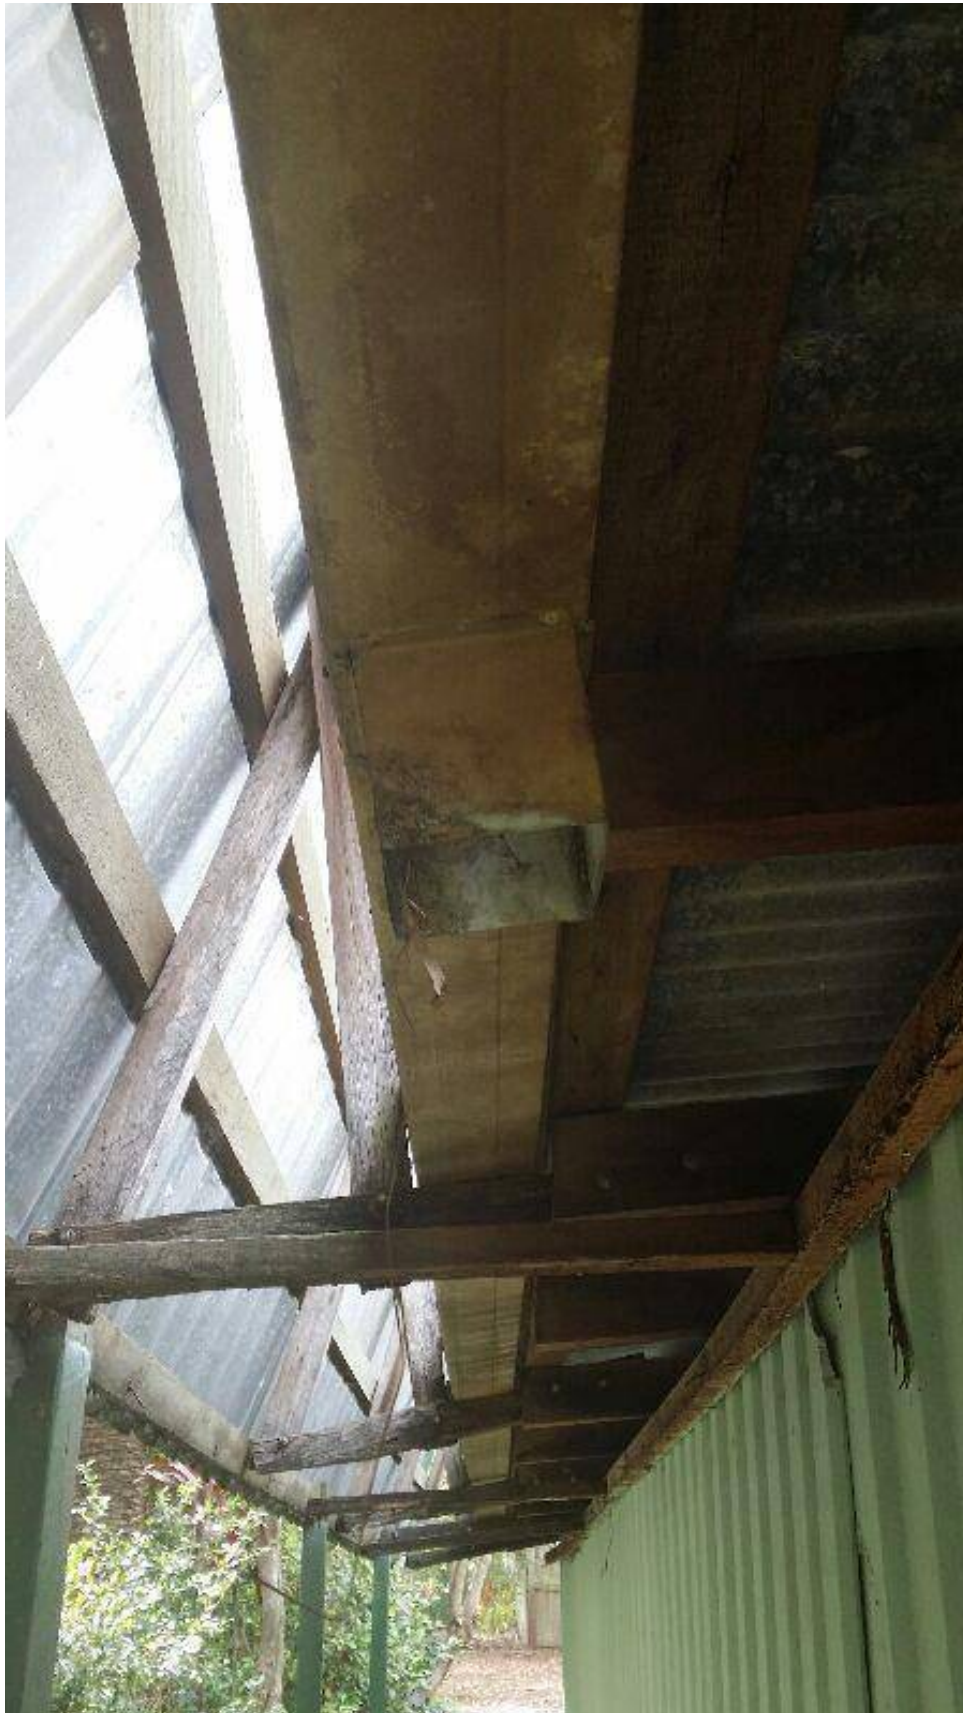
Some downpipes do not appear to be connected to a stormwater dispersal system. This should be rectified.

A licensed plumber should be called to make a further evaluation and repairs or rectification as needed.

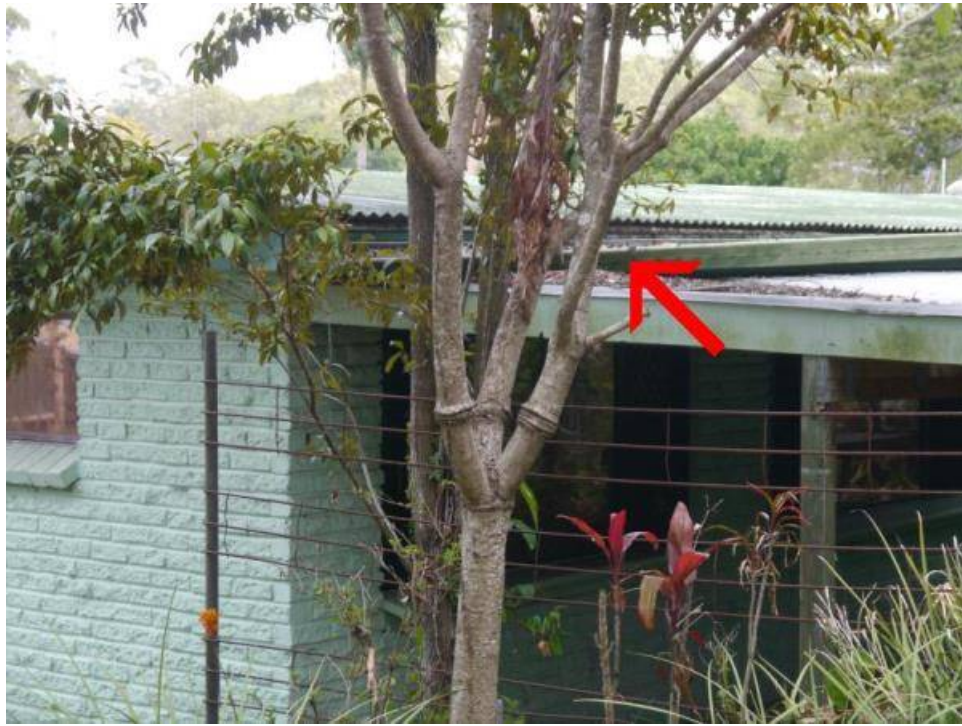
Gutters are damaged and should be repaired or replaced as necessary.

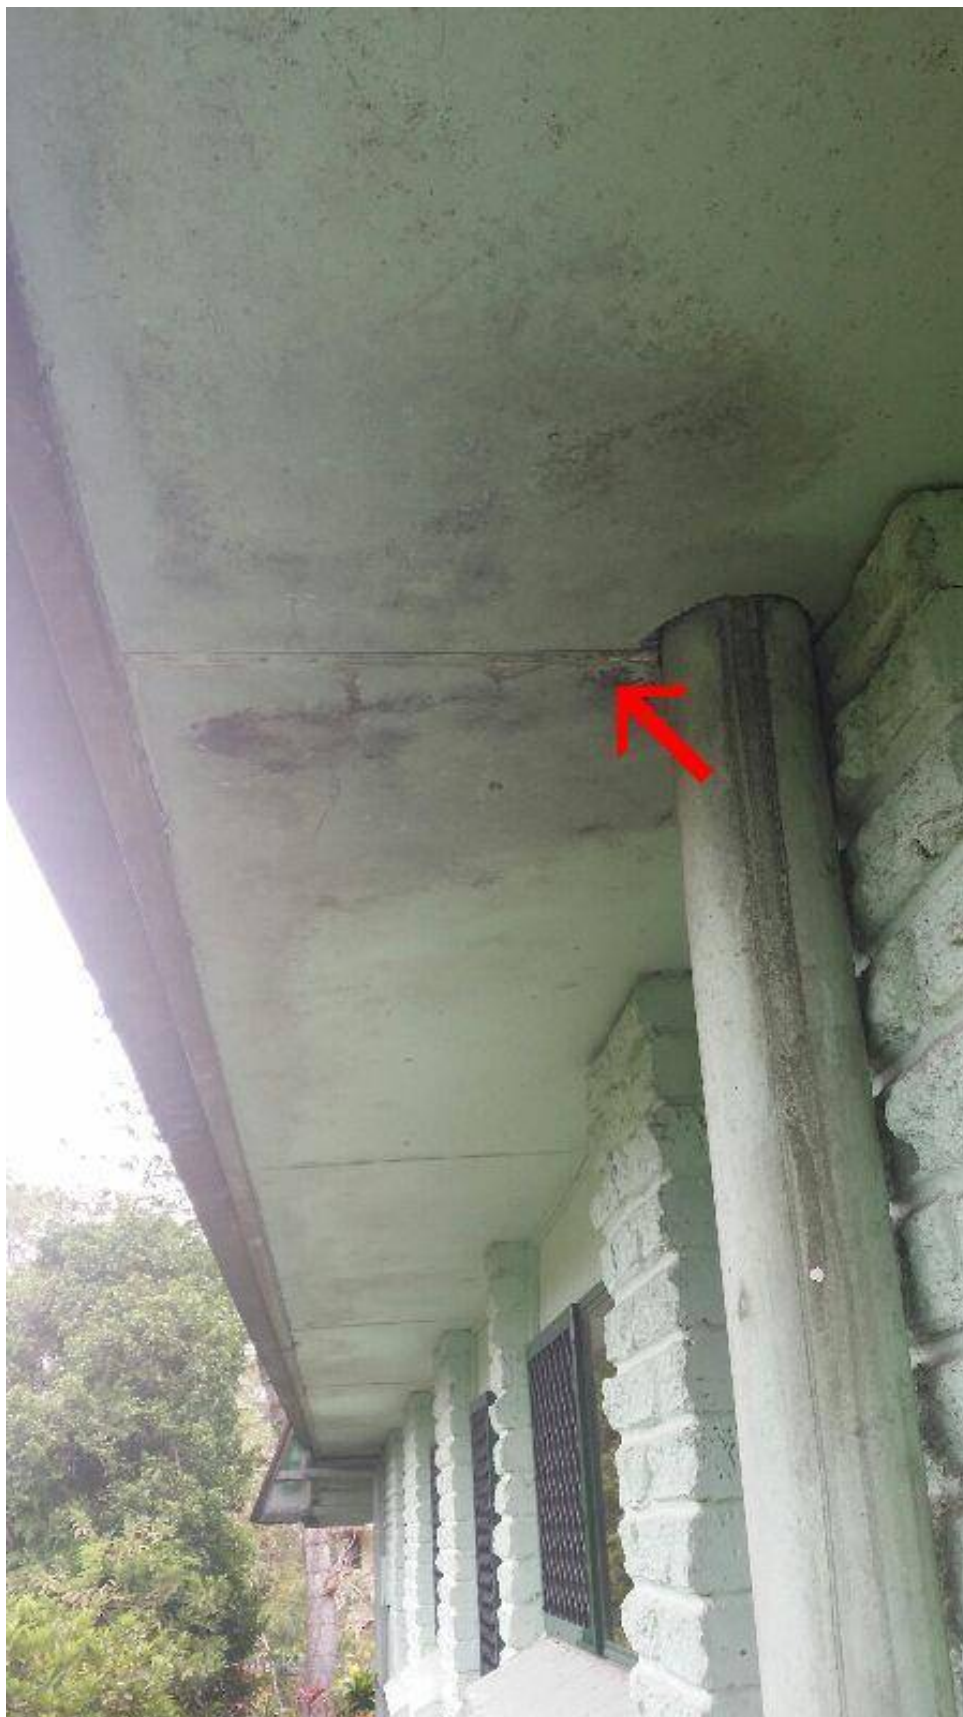
The overall condition of the eaves lining is poor. Moderate wet rot decay is present to timber eaves lining boards. Maintenance or replacement is required. Asbestos cement sheeting. Although we have not tested materials, due to the age and type of material our knowledge of construction materials and their physical properties we believe these items may contain asbestos. Asbestos material should not be disturbed or damaged and should be kept well maintained and sealed to prevent exposure. Due to the nature of asbestos and the hazards to health it can

pose, it should only be removed or modified by a licensed asbestos removal contractor. Due to the use of bonded and friable asbestos wall sheeting we suggest that samples should be taken and laboratory testing done to confirm material type and classification.

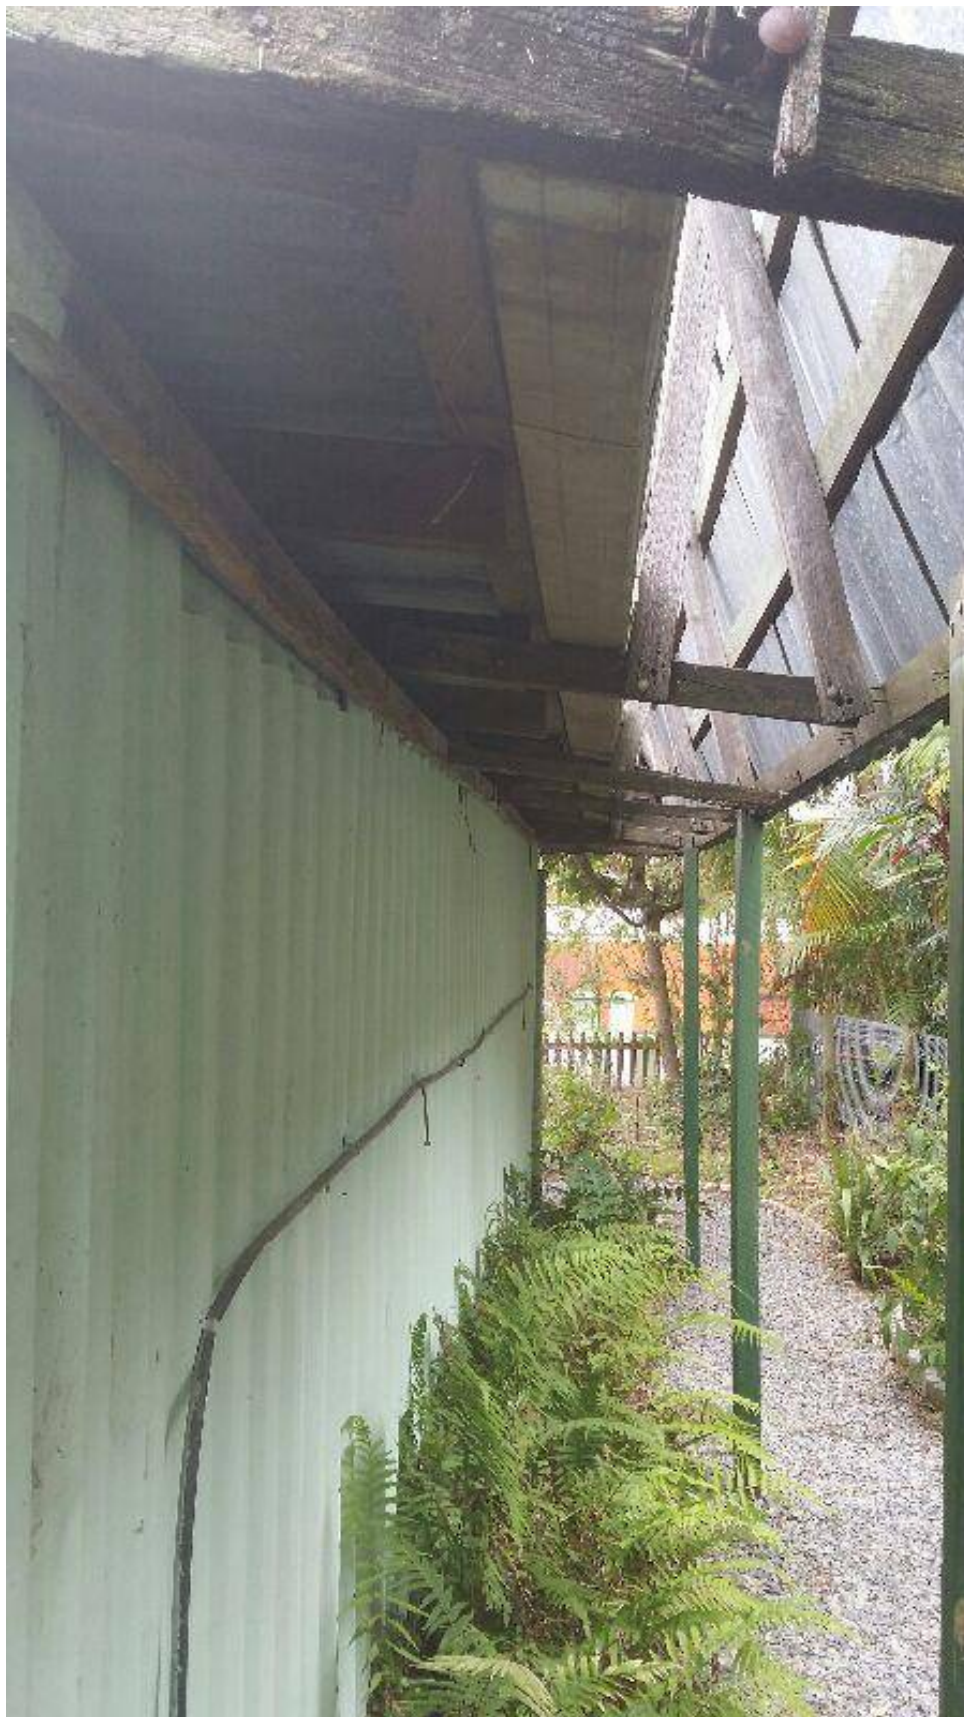
Some eaves linings are missing and should be replaced.

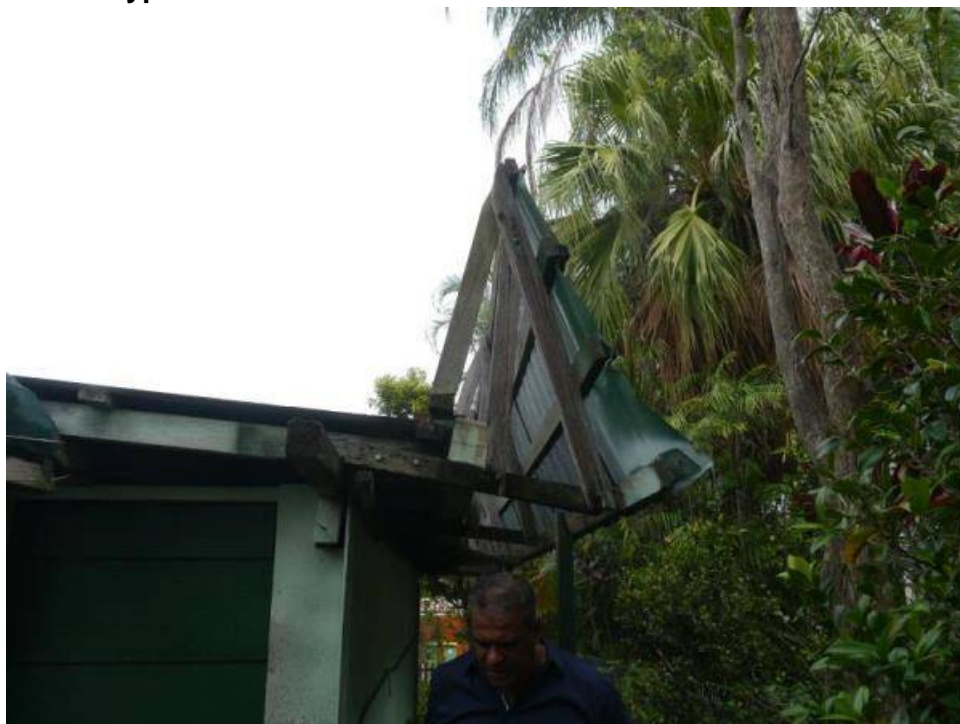
The overall condition of the fascias/bargeboards is poor. Some fascias/bargeboards are missing and should be replaced/installed.

A licensed builder should be called to make a further evaluation and repairs or rectification as needed.

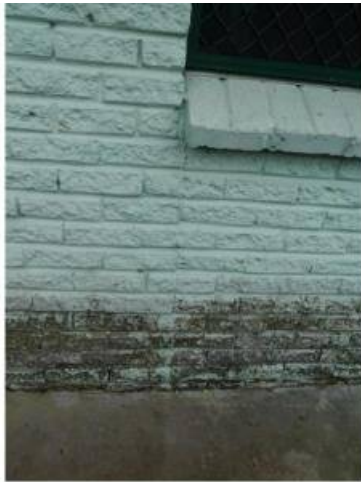
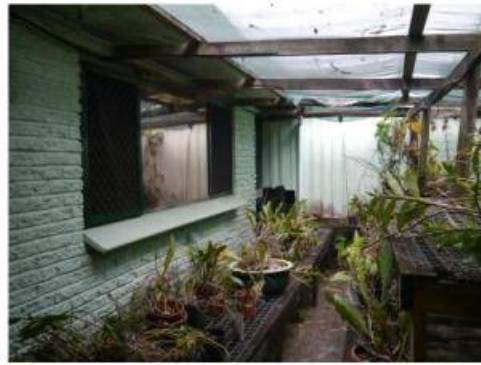
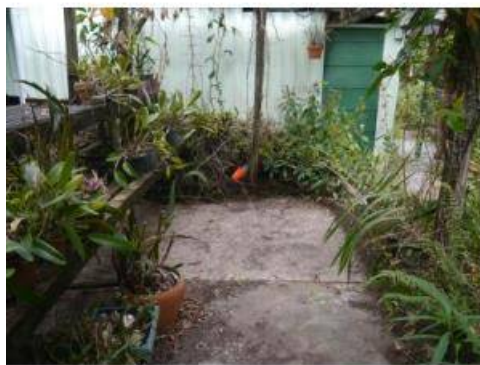
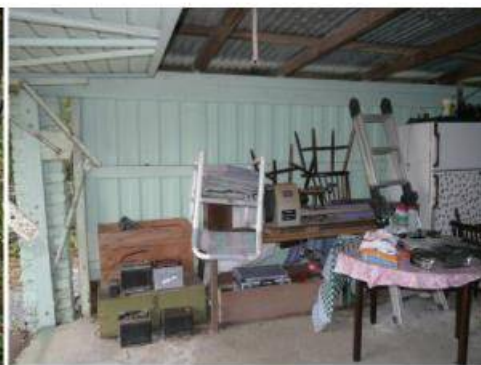
The base of some walls are below the external soil levels and may be subject to lateral dampness or water entry. Recommend soil levels be lowered or the area be closely monitored for water entry/penetration.

A licensed builder should be called to make a further evaluation and repairs or rectification as needed.

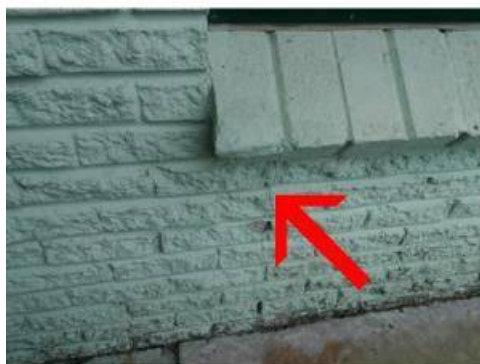
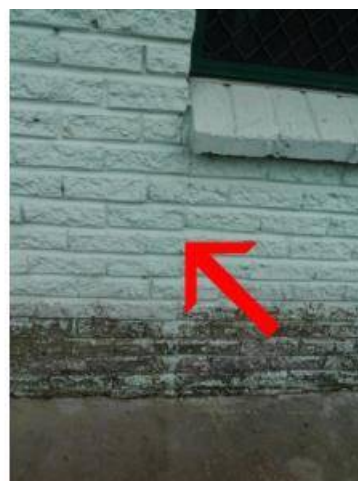
Cracks are evident. Visible cracking has been categorized as an appearance defect. Cracking of a building element is an appearance defect where in the opinion of the inspector the appearance of the element is blemished however, the expected consequence of this cracking is unknown until further information is obtained.

Cracking can be expected in a building of this age and construction.

We recommend an engineer be engaged to comment upon and offer further advise regarding the above issue.

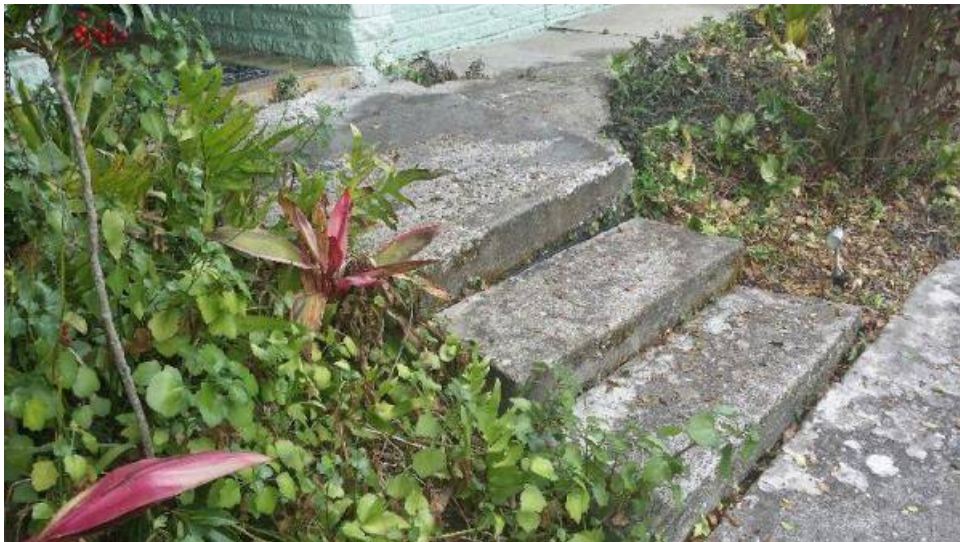
The stairs are constructed primarily from concrete. The overall condition of the stairs is poor.

A licensed builder should be called to make a further evaluation and repairs or rectification as needed.

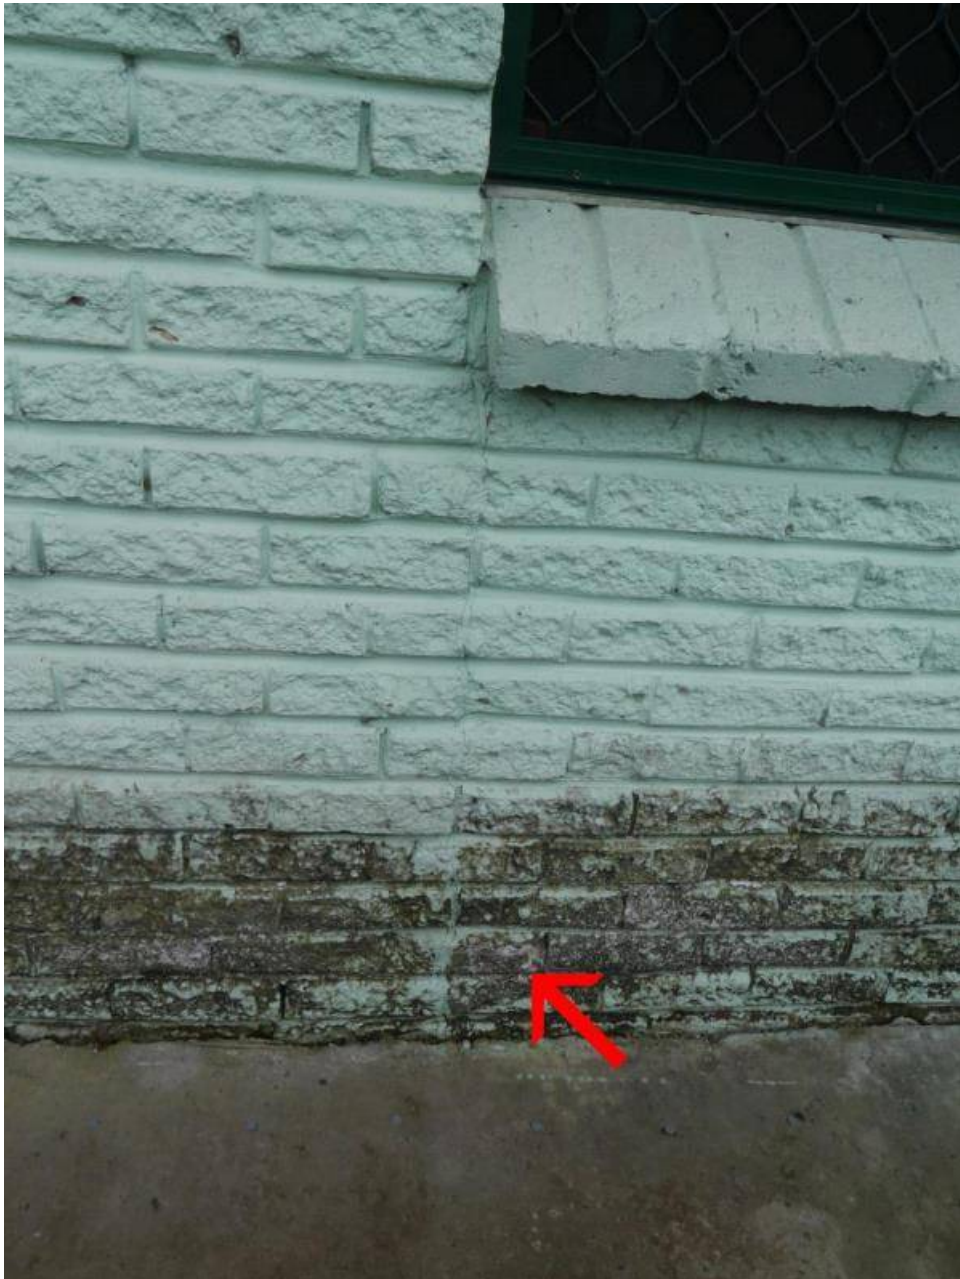
A damp proof coursing material could not be identified. Where a damp proof coursing material is not visible or cannot be identified, rising damp may become a future problem. Rising damp is evident in the masonry walls to the following elevation. The damp proof coursing material should be replaced and quotations should be obtained from a suitably qualified contractor. Cost to replace damp proof coursing material can range upwards from \$150.00 per linear metre. The location of the rising damp was the following area.

A licensed builder should be called to make a further evaluation and repairs or rectification as needed.

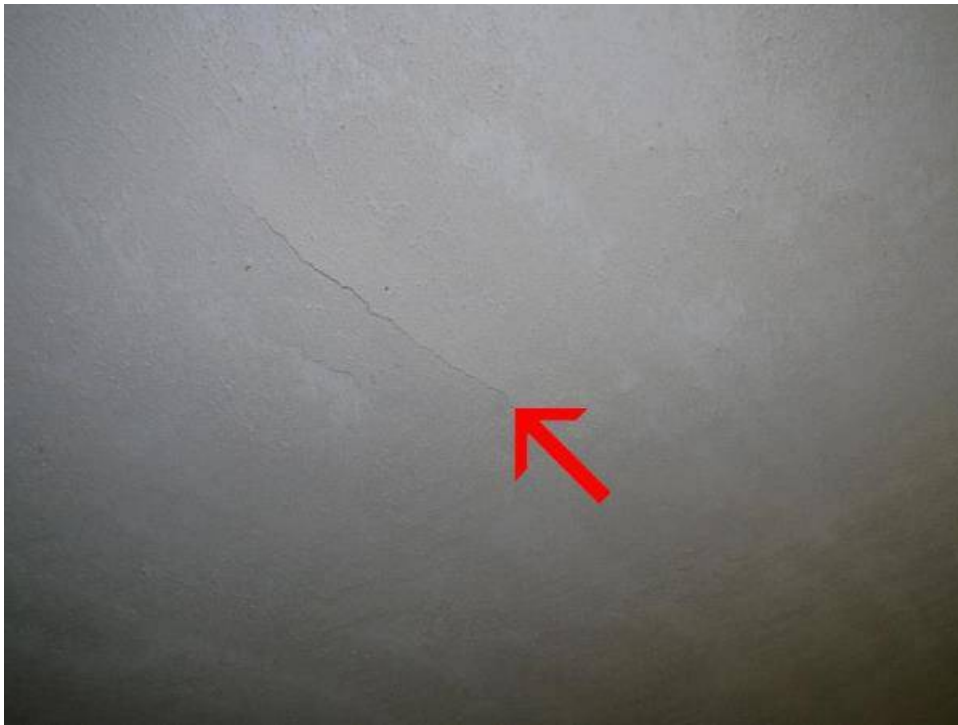
Defective surfaces were noted and maintenance will be required.

A licensed builder should be called to make a further evaluation and repairs or rectification as needed.

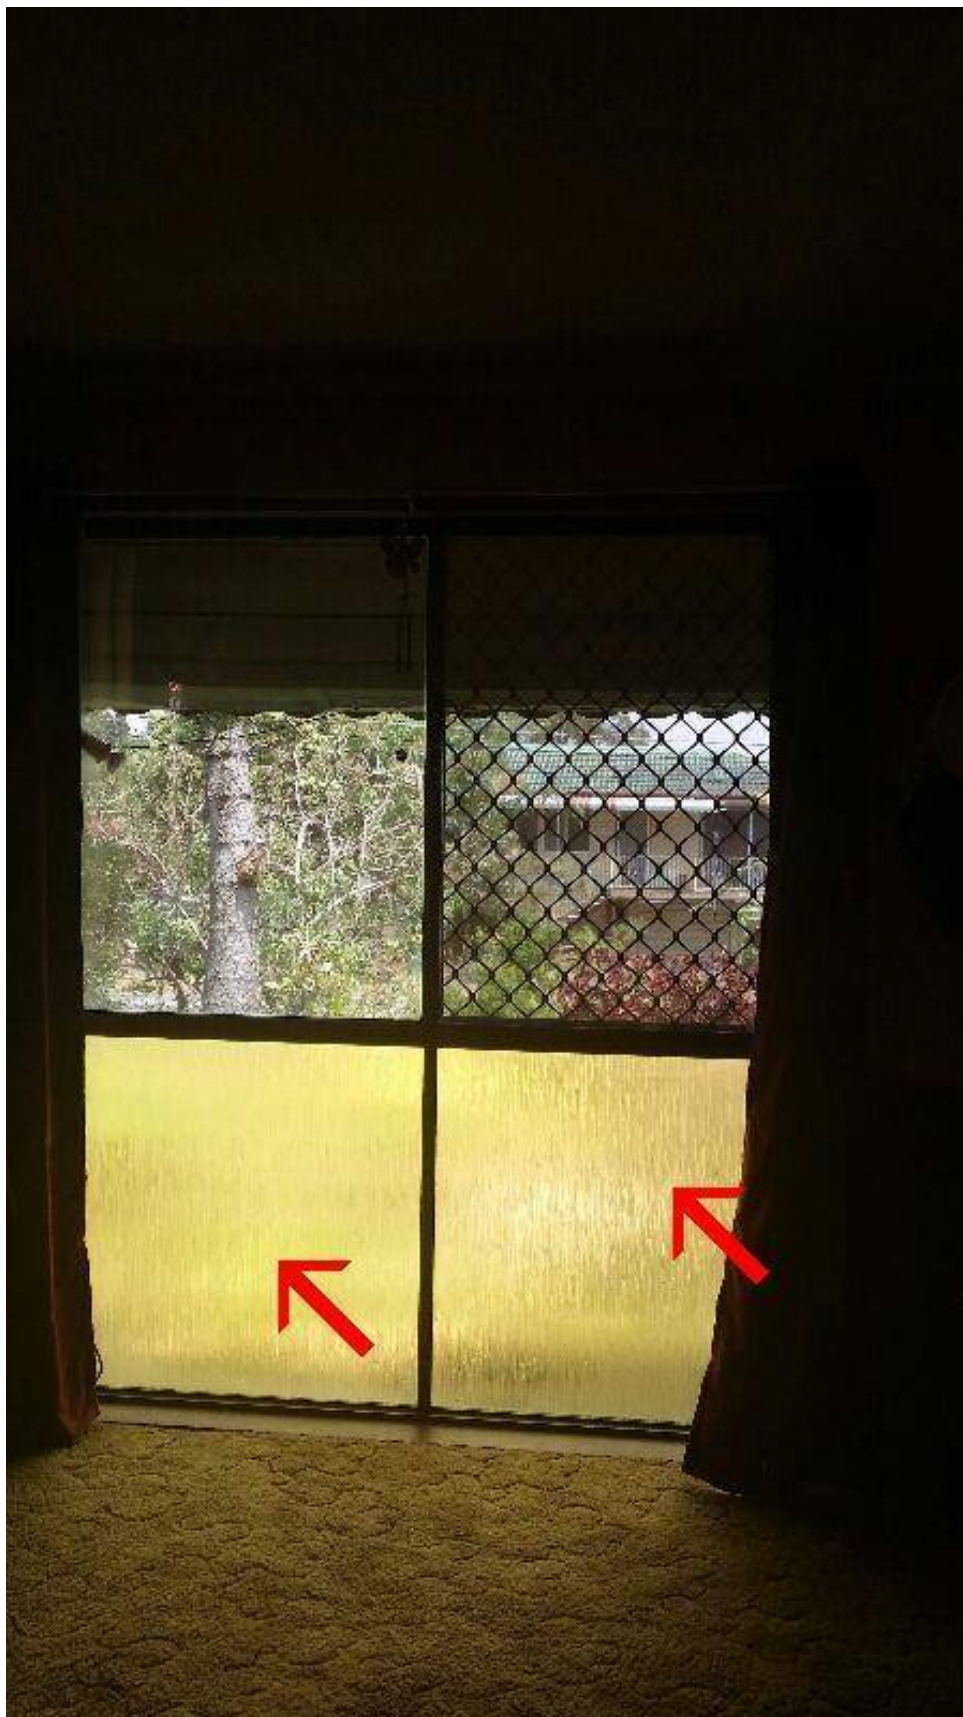
In the interests of safety, shatterproof film or safety glass should be installed to large glass panes within 600mm of the floor and 300mm of a doorway.

A licensed glazier should be called to make a further evaluation and repairs or rectification as needed.

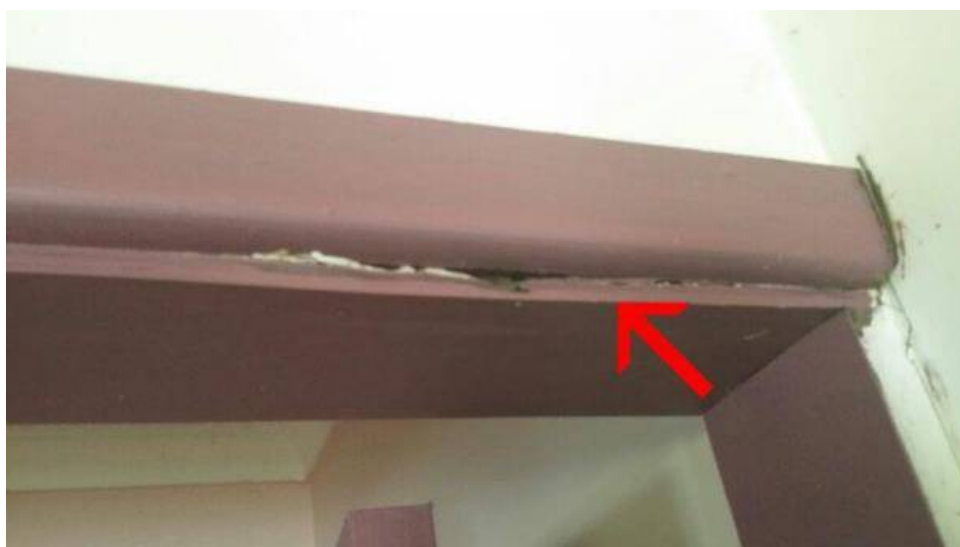
Evidence of what appears to be timber pest attack was noted.

A licensed builder should be called to make a further evaluation and repairs or rectification as needed.

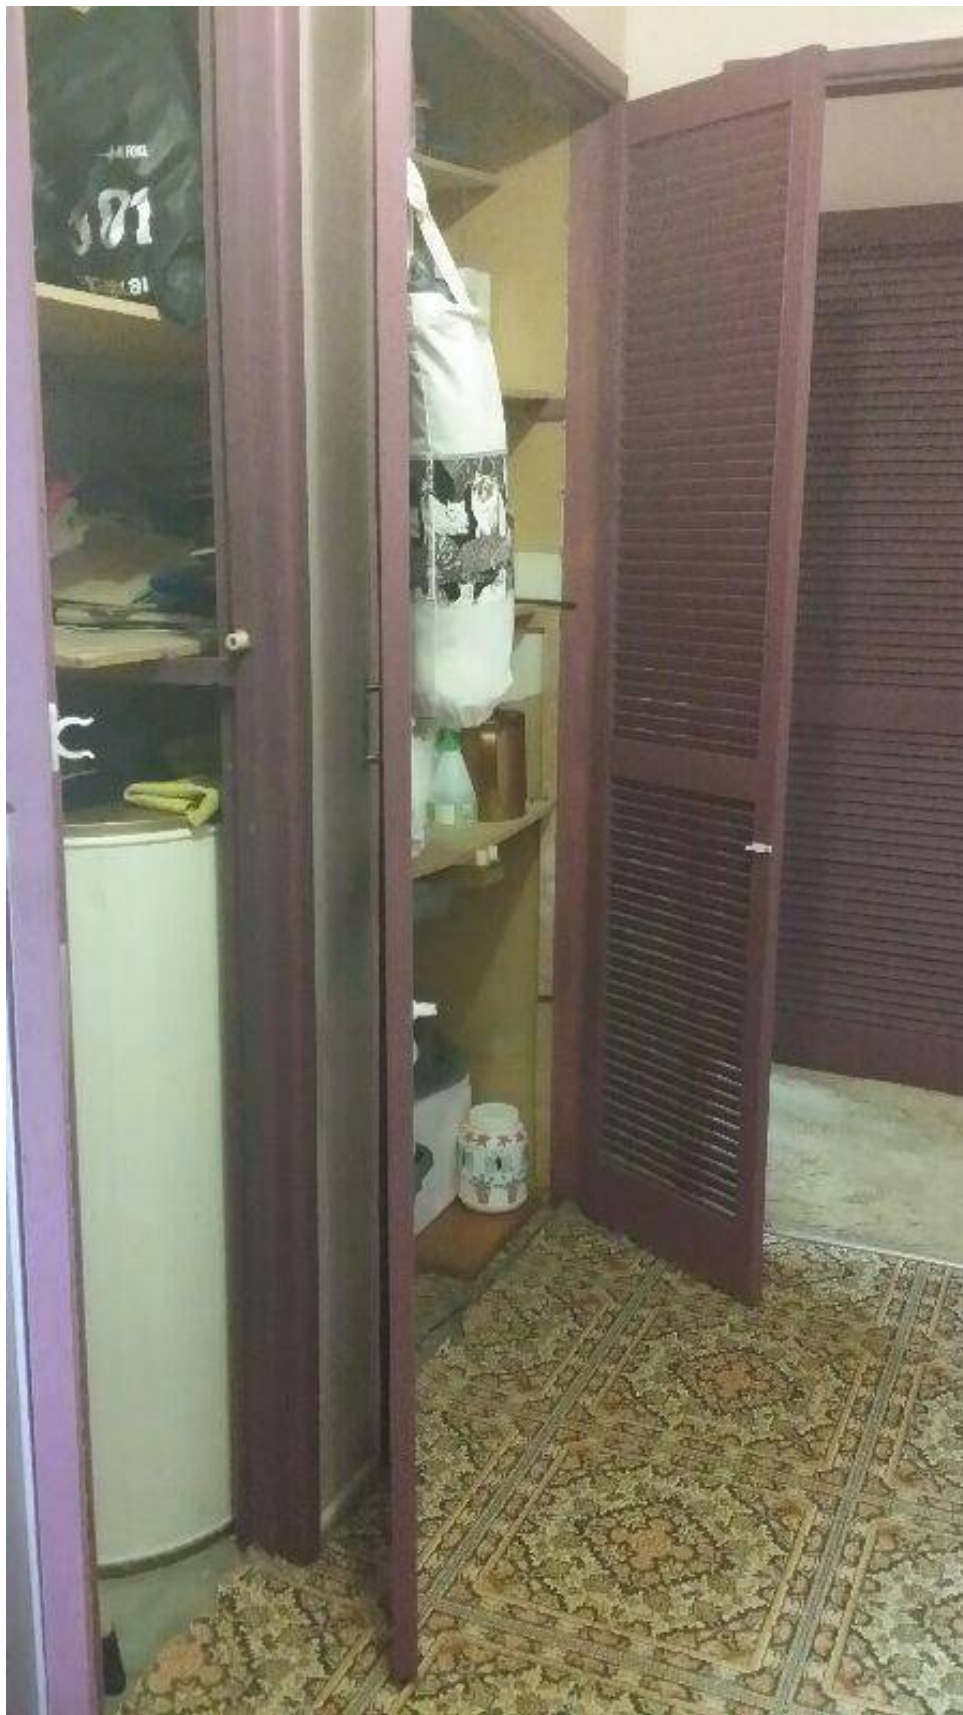
Laundry: The condition of the built-in Wardrobes/Linen/Broom Cupboard is generally poor.

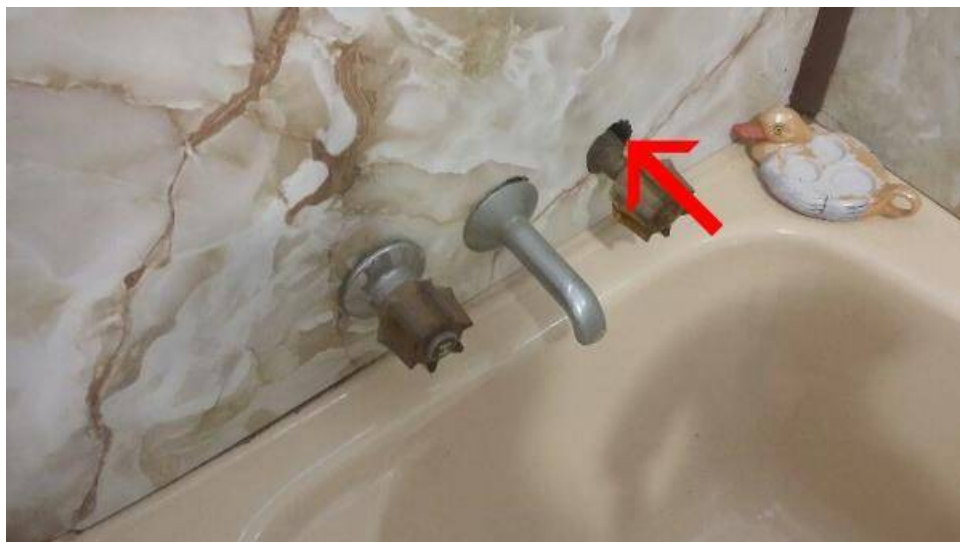
The tap and tap surrounds do not cover the tile cut outs. This is due to poor workmanship and this could allow water penetration behind the tiled areas. A flexible sealant should be provided to the gaps between internal tiles at vertical and horizontal wall and floor joints to allow for expansion and contraction between surfaces preventing damage between tile surfaces controlling and eliminating potential pressure on membranes behind tiles from uncontrolled movement which may lead to membrane damage, also provides an acceptable finish and resist water penetration in areas where free moisture may flow during normal use as in areas such as shower screens, basins and sinks where limited controlled moisture maybe present also in kitchen, laundry and bathroom bench tops and vanities, these joints are not provided to perform as a substitute for water proofing barriers as found in wet areas behind the tiles. These joints as described in standards are to be typically 6mm which is rarely complied with in domestic construction.

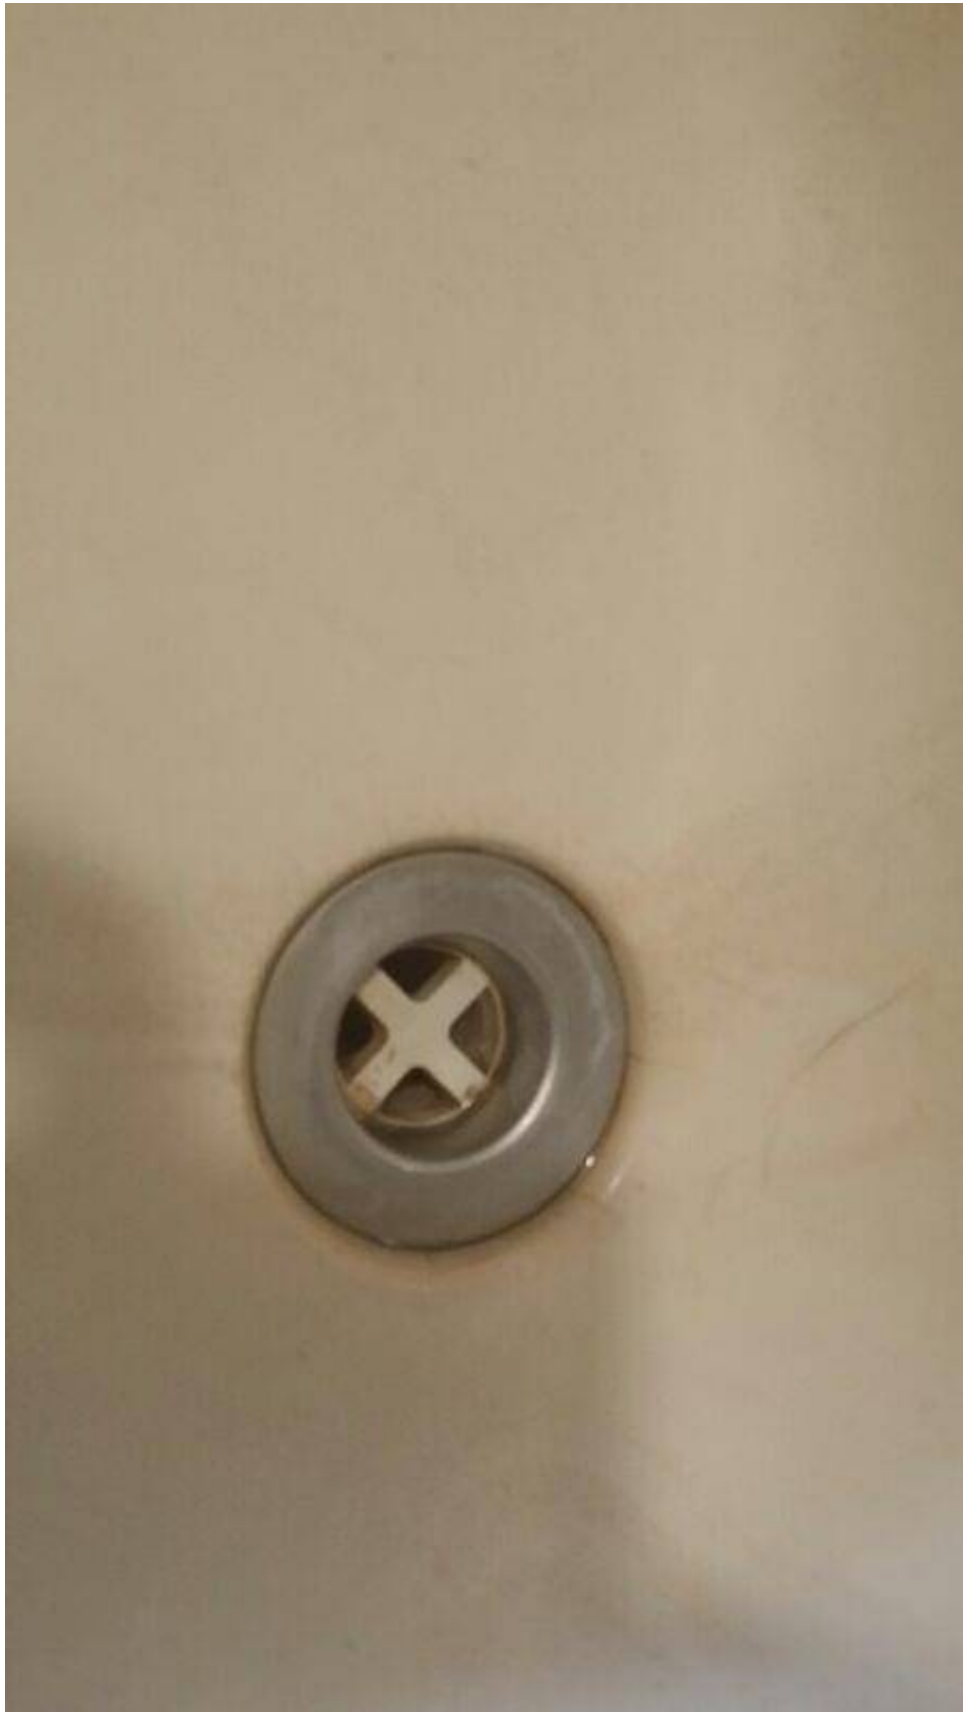
Crazing to the surface of the basin.

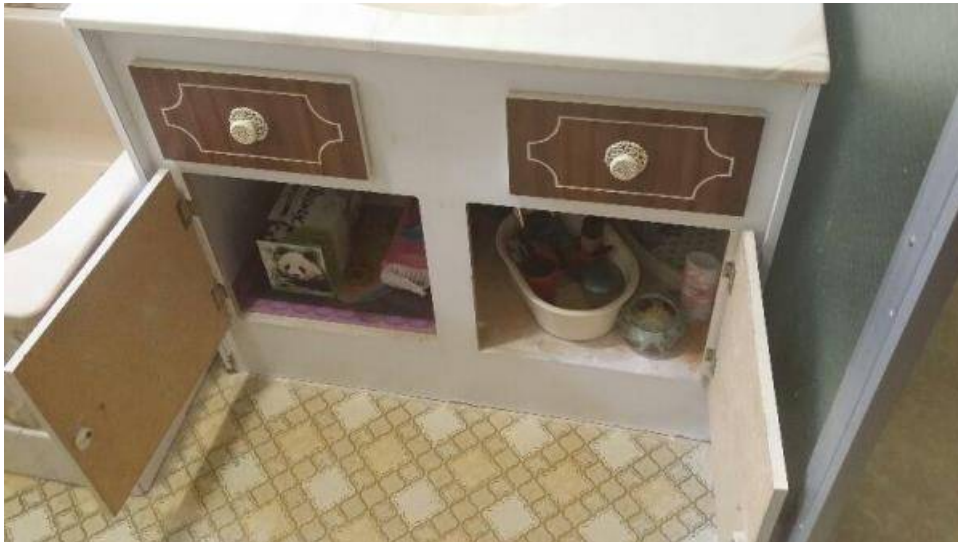
The condition of the vanity unit is generally poor.

A licensed builder should be called to make a further evaluation and repairs or rectification as needed.

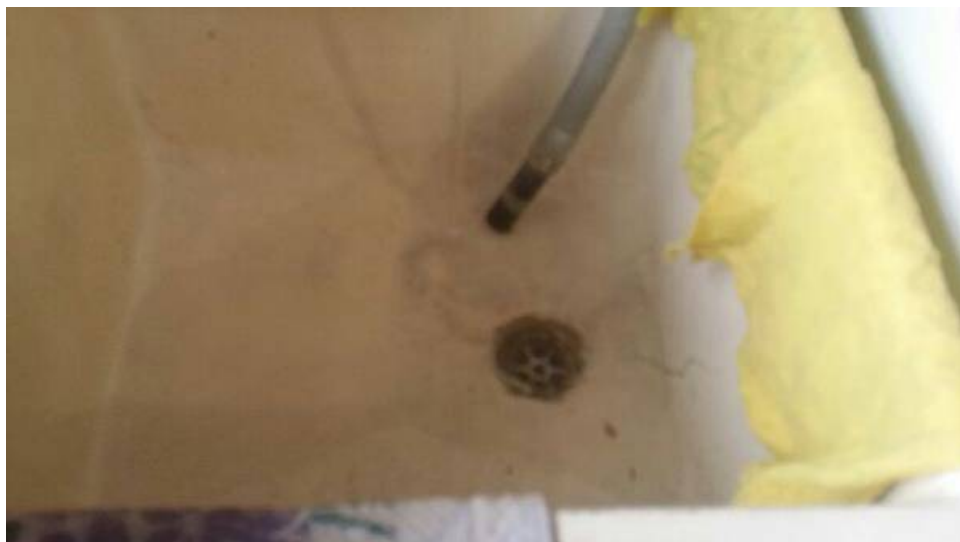
The tub is damaged.

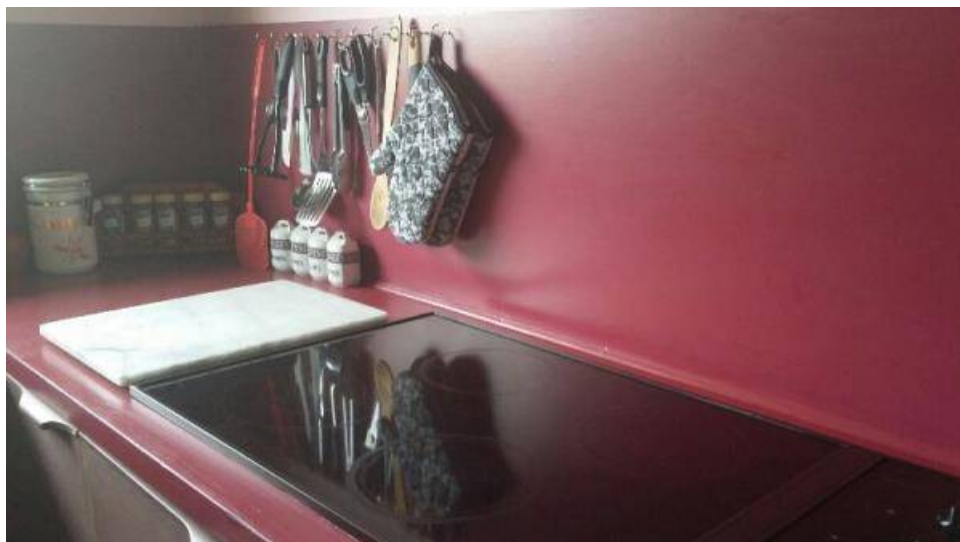
Tiles are not present to wet areas. Recommend tiles be installed to prevent water penetration.

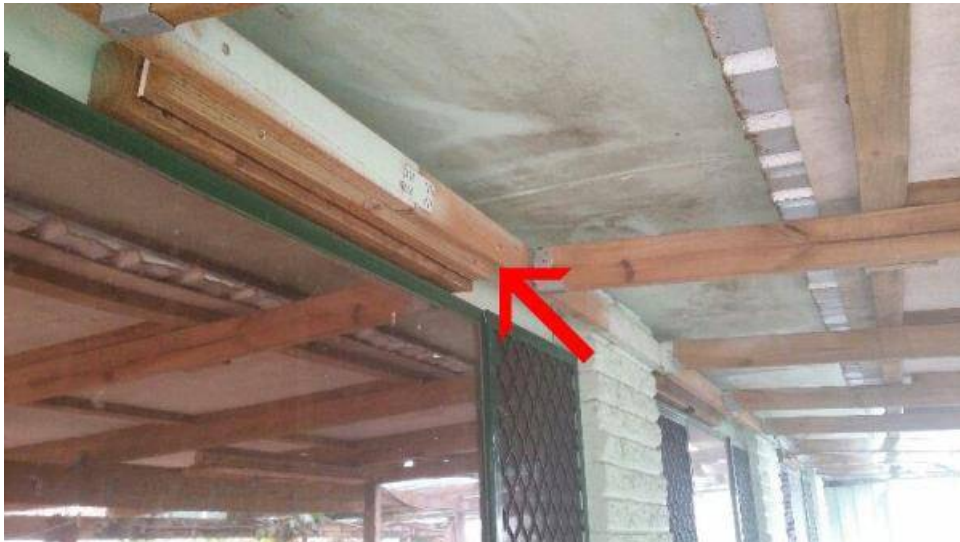
Constructed from timber. The general condition of this structure is poor. Repairs or maintenance is required. The method of attachment lends itself to potential failure without warning and should be rectified.

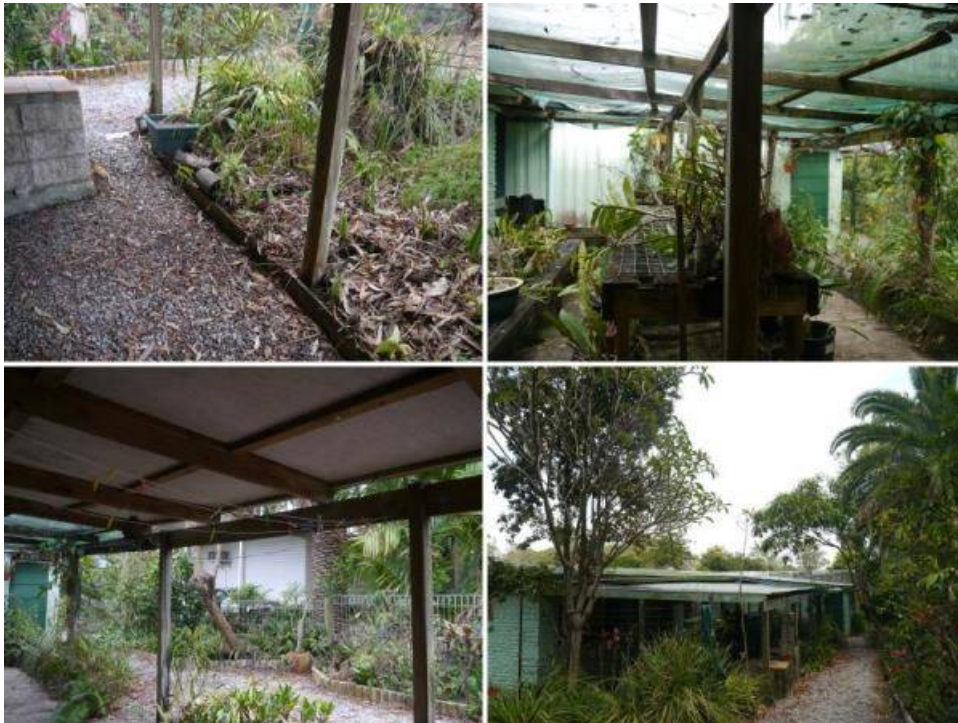
Gutters and stormwater dispersal system are not connected to this roof. Some timbers of this structure are in contact with soil and or pavements. This situation can allow concealed termite entry and we recommend that modifications be made.

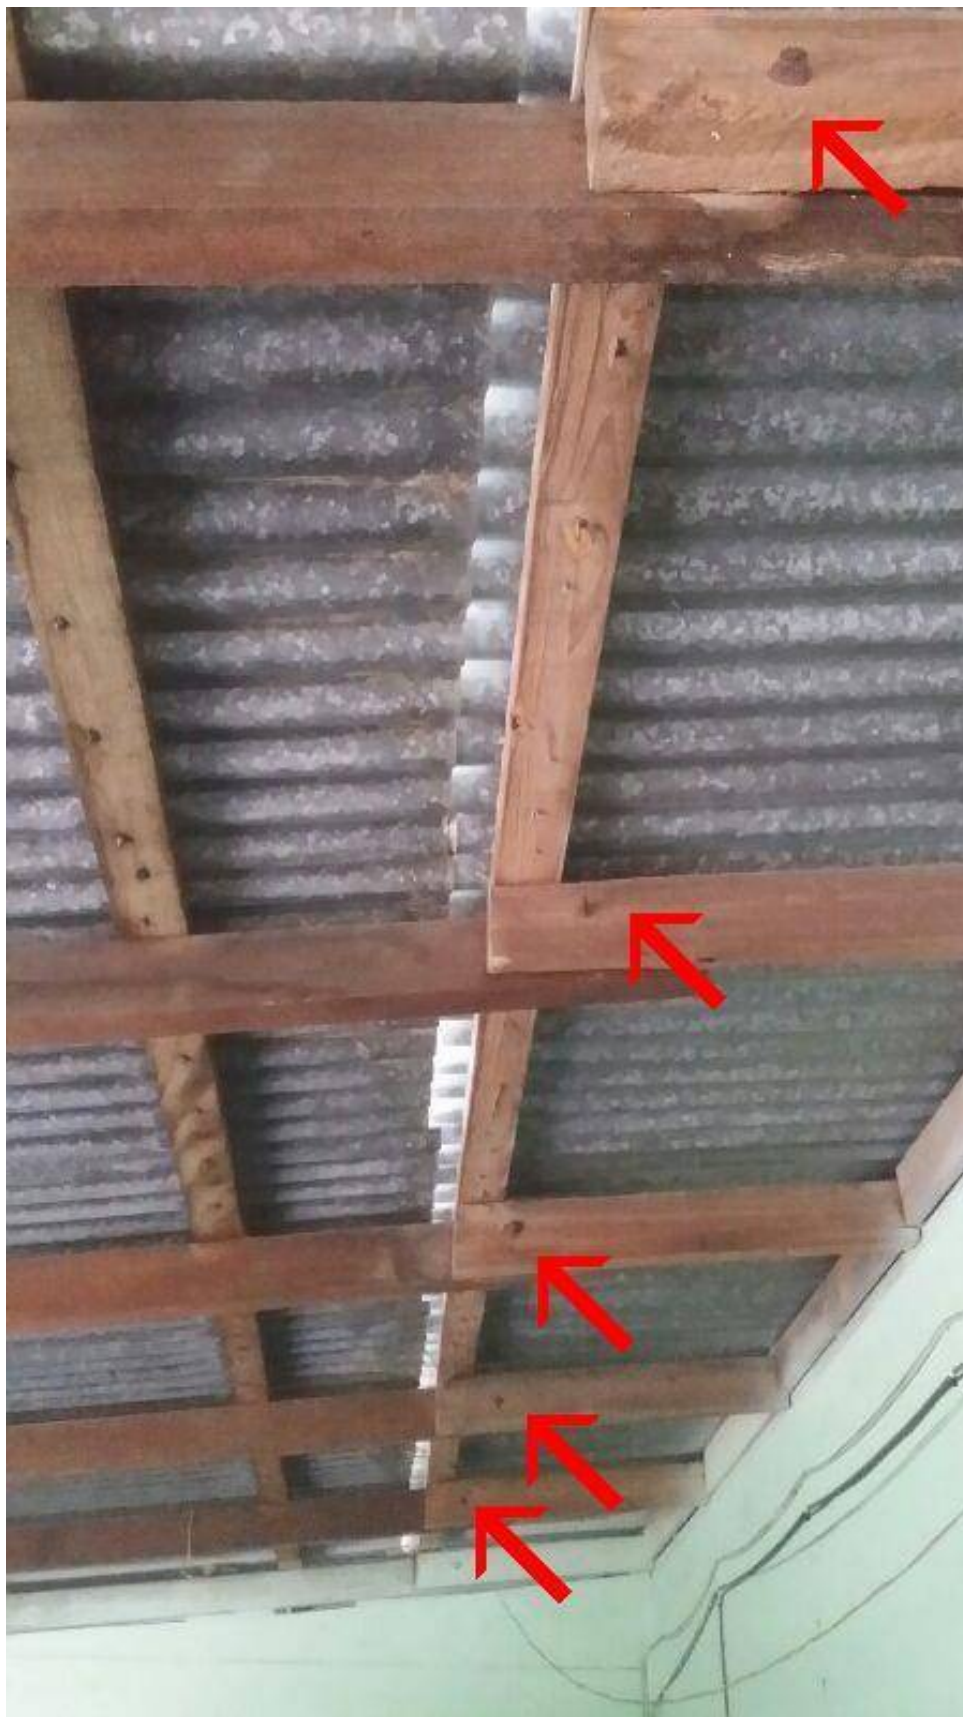
The overall condition of the garage is poor. The roof sheets are end lapped this promotes Corrosion and premature failure in roof sheets.

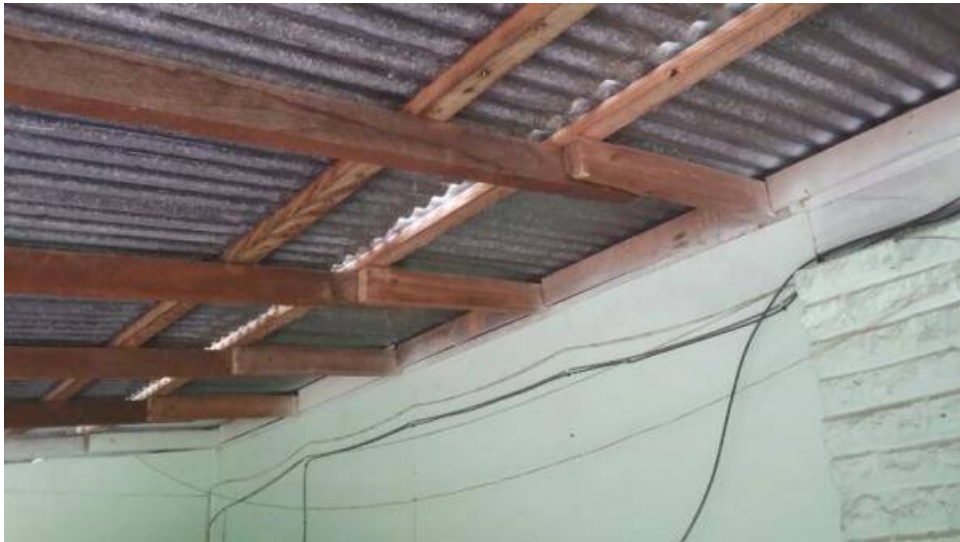
The roof is of skillion style construction. Rafter to tail Connection appears to be inadequate we suggest additional support to be provided,
