VISUAL BUILDING and PEST INSPECTION REPORT	6
ROOF SYSTEM EXTERNAL	9
EXTERIOR	16
INTERIOR CONDITION REPORT	19
BATHROOMS	25
TOILETS	29
LAUNDRY	35
KITCHEN	37
DECKS, PERGOLAS, BALCONIES, VERANDAHS, AWNINGS	39
GARAGING	41
ROOF SYSTEM INTERNAL	46
FOOTINGS	46
SITE	46
SERVICES	48
Important Information	50
VISUAL TIMBER PEST INSPECTION PART 2 of REPORT	54
BRIEF SUMMARY	56
ROOF	57
INTERIOR	57

Example Qld

1113 Example 5 bldpst

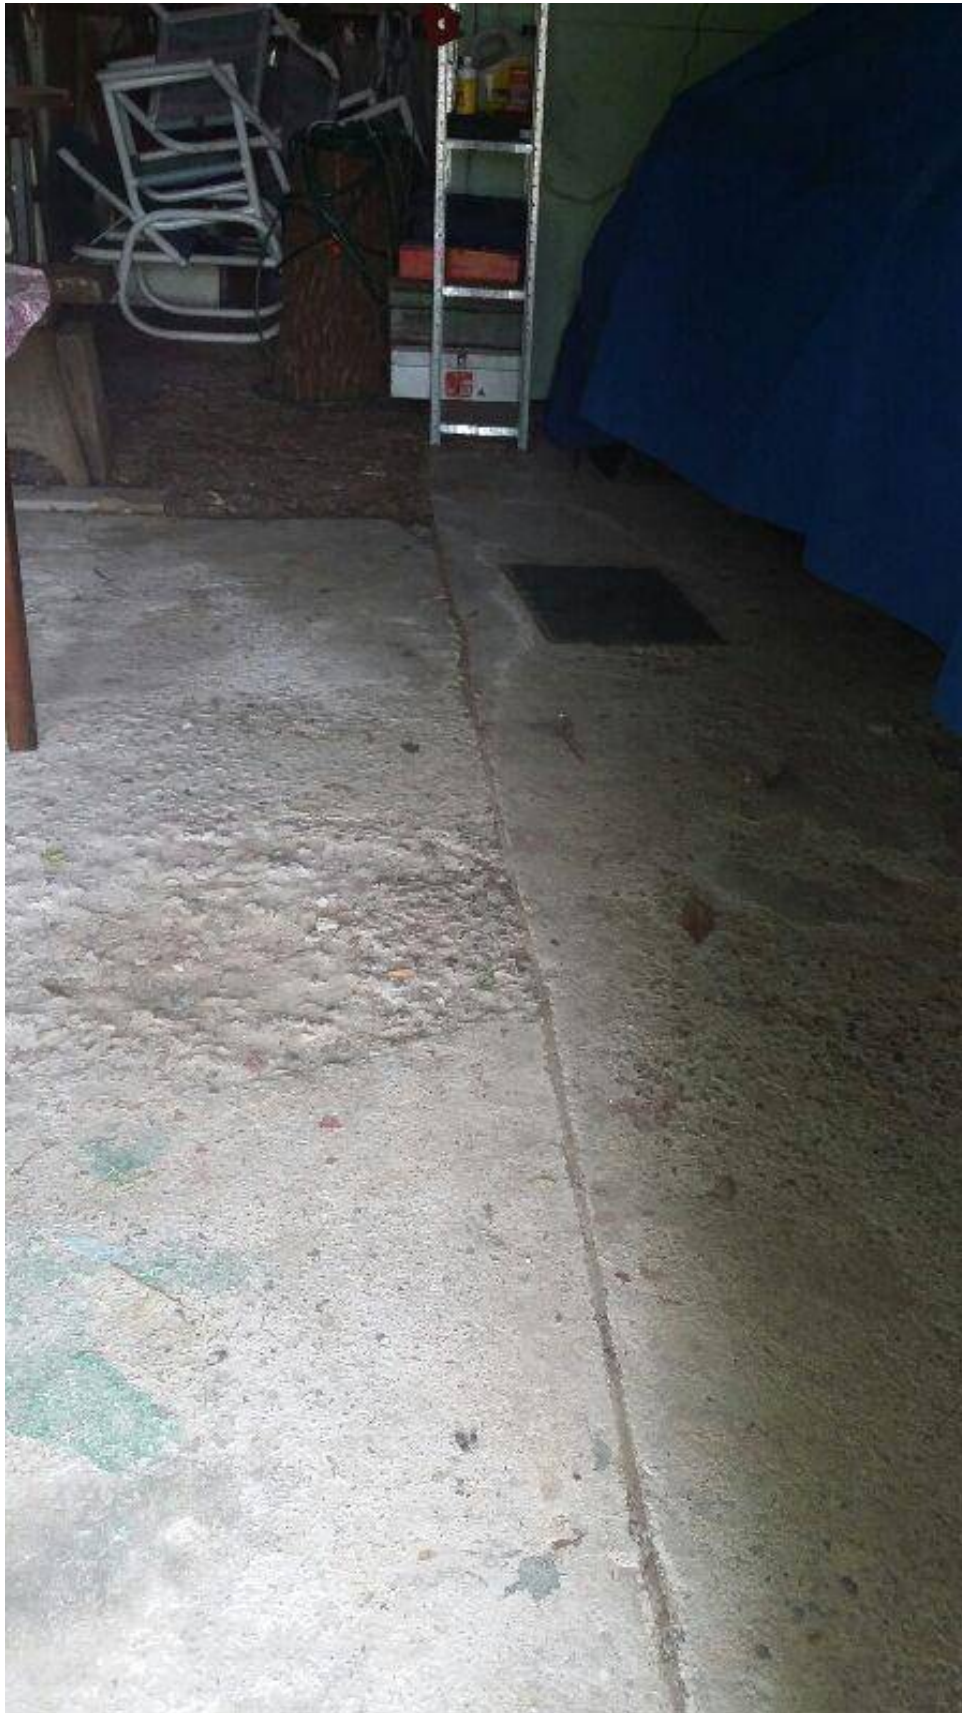
The concrete floor is generally in poor condition. A dirt floor is present in this area.

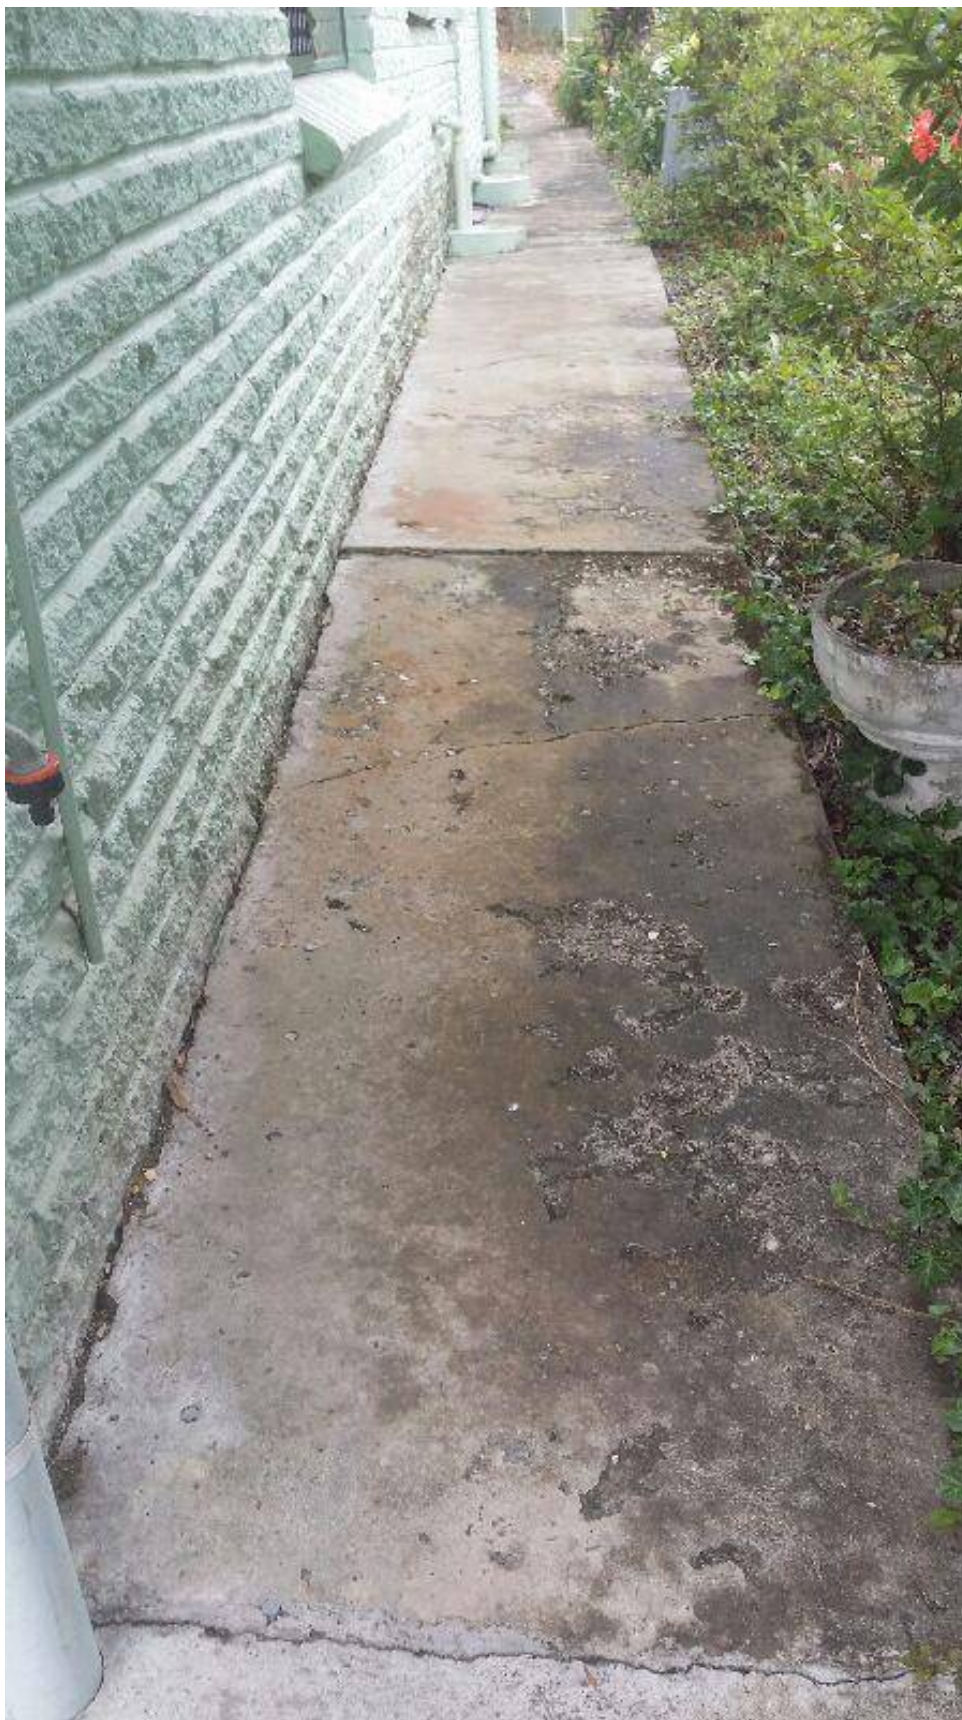
The paths/paved areas are constructed mainly of; Concrete: The concrete paths/paved areas have some visible cracking that should be monitored for further movement. The concrete paths/paved areas have subsided in areas and will require repair. This may present a tripping hazard. Rectification should be considered.

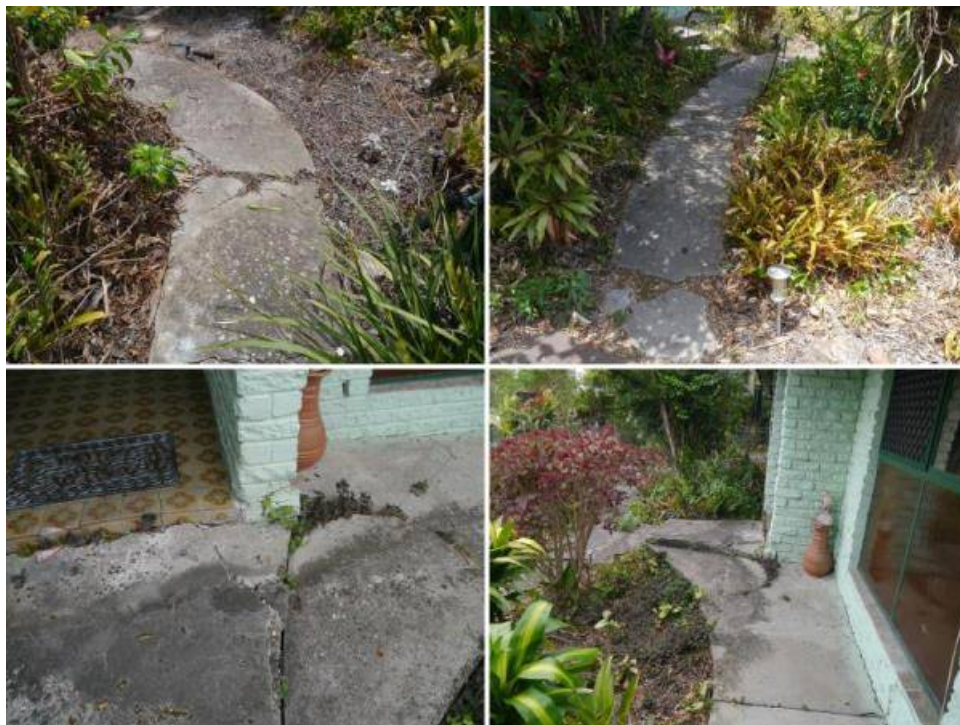
The concrete paths/paved areas are in poor condition.

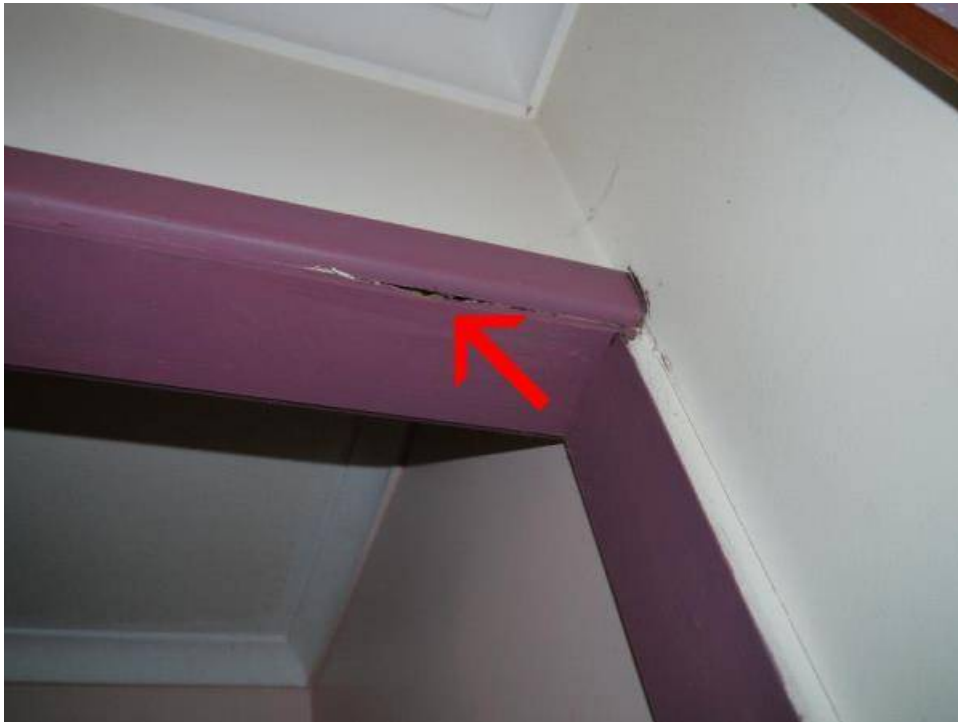
Yes - Inspection revealed currently inactive termite attack (damaged timbers and/or termite workings) within this area including but not necessarily limited to the following timbers and the areas listed below.

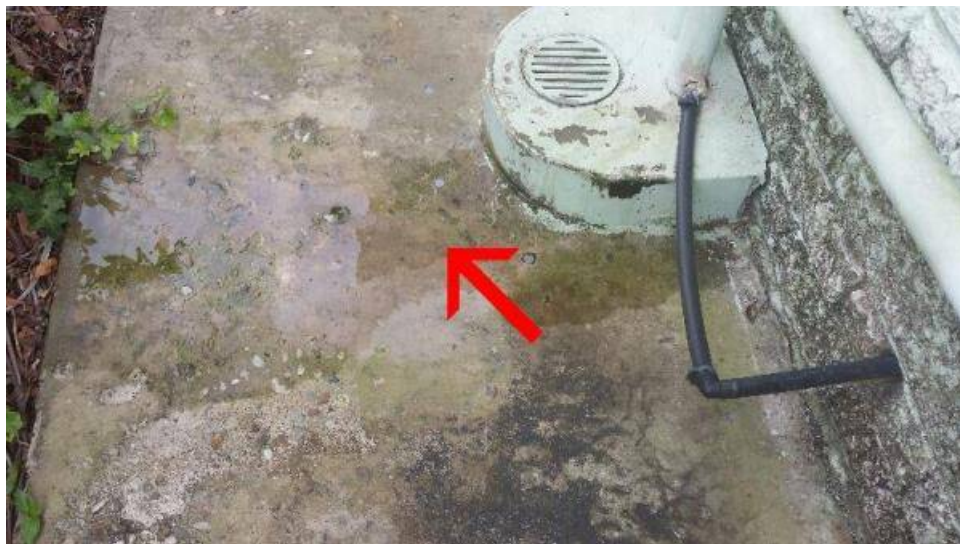
Water is dripping on pavement adjacent to external wall of building. The level of some external paths, paved areas or soil is either higher than, or at a similar level, as that of the internal floors or footing lines where external brickwork is placed, it is our experience that most termite entry occurs between physical termite barriers, finished ground levels and top of footings. This situation could allow concealed termite entry. We strongly recommend if possible the lowering of these to below the internal floor level to reduce the risk of concealed termite entry alternatively an approved proprietary in ground chemical pest barrier should be installed and maintained on a regular basis. External cladding is in contact with soil. This can allow concealed termite entry and we recommend modifications be made so that soil is not in contact with cladding.

Some gutters and/or downpipes appear to discharge rainwater directly adjacent to the foundations of the structure. These should be connected to a stormwater dispersal system.

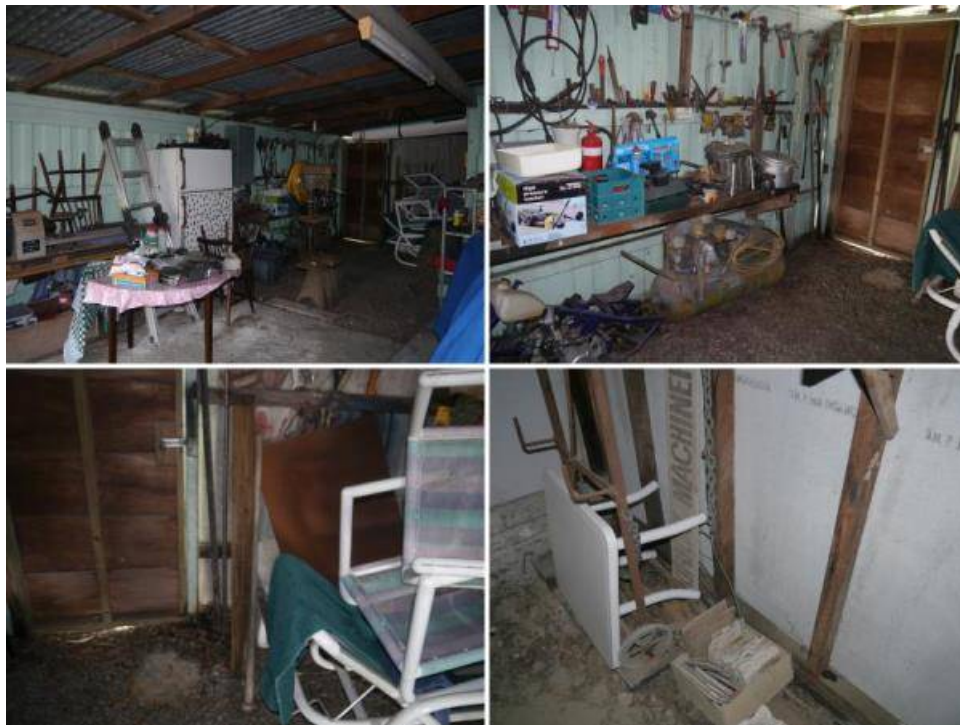
Inspection within the garage was severely restricted by stored items. These must be removed to enable a more complete report to be submitted. The garage is partially lined preventing inspection to some framing timbers.

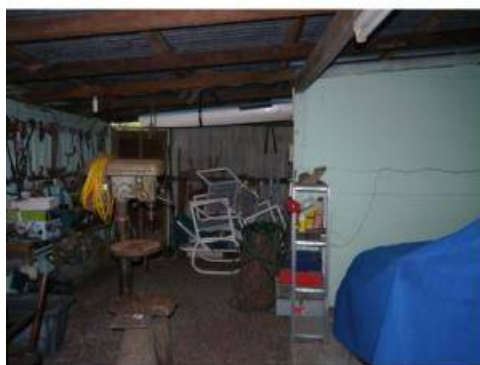
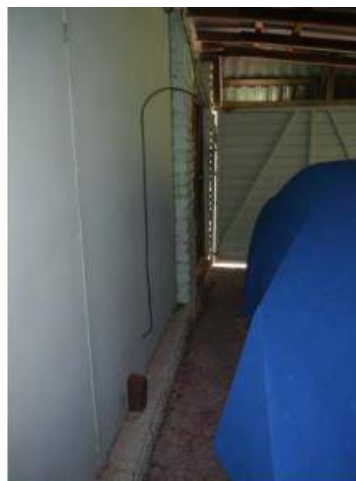
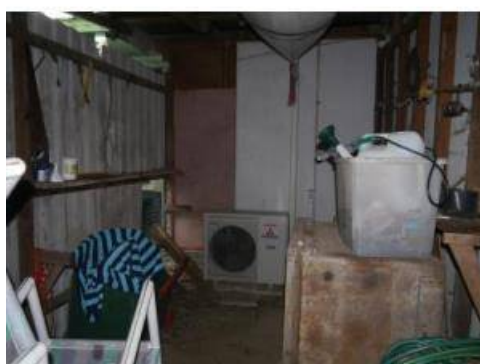
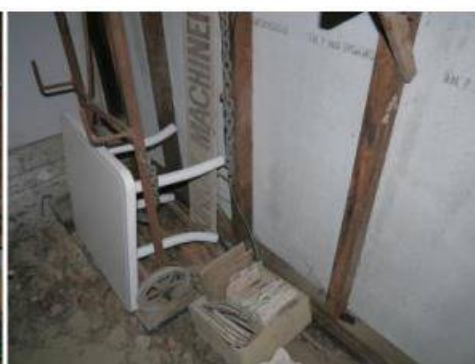
External cladding is in contact with soil. This can allow concealed termite entry and we recommend modifications be made so that soil is not in contact with cladding.

Some gutters and/or downpipes appear to discharge rainwater directly adjacent to the foundations of the structure. These should be connected to a stormwater dispersal system.

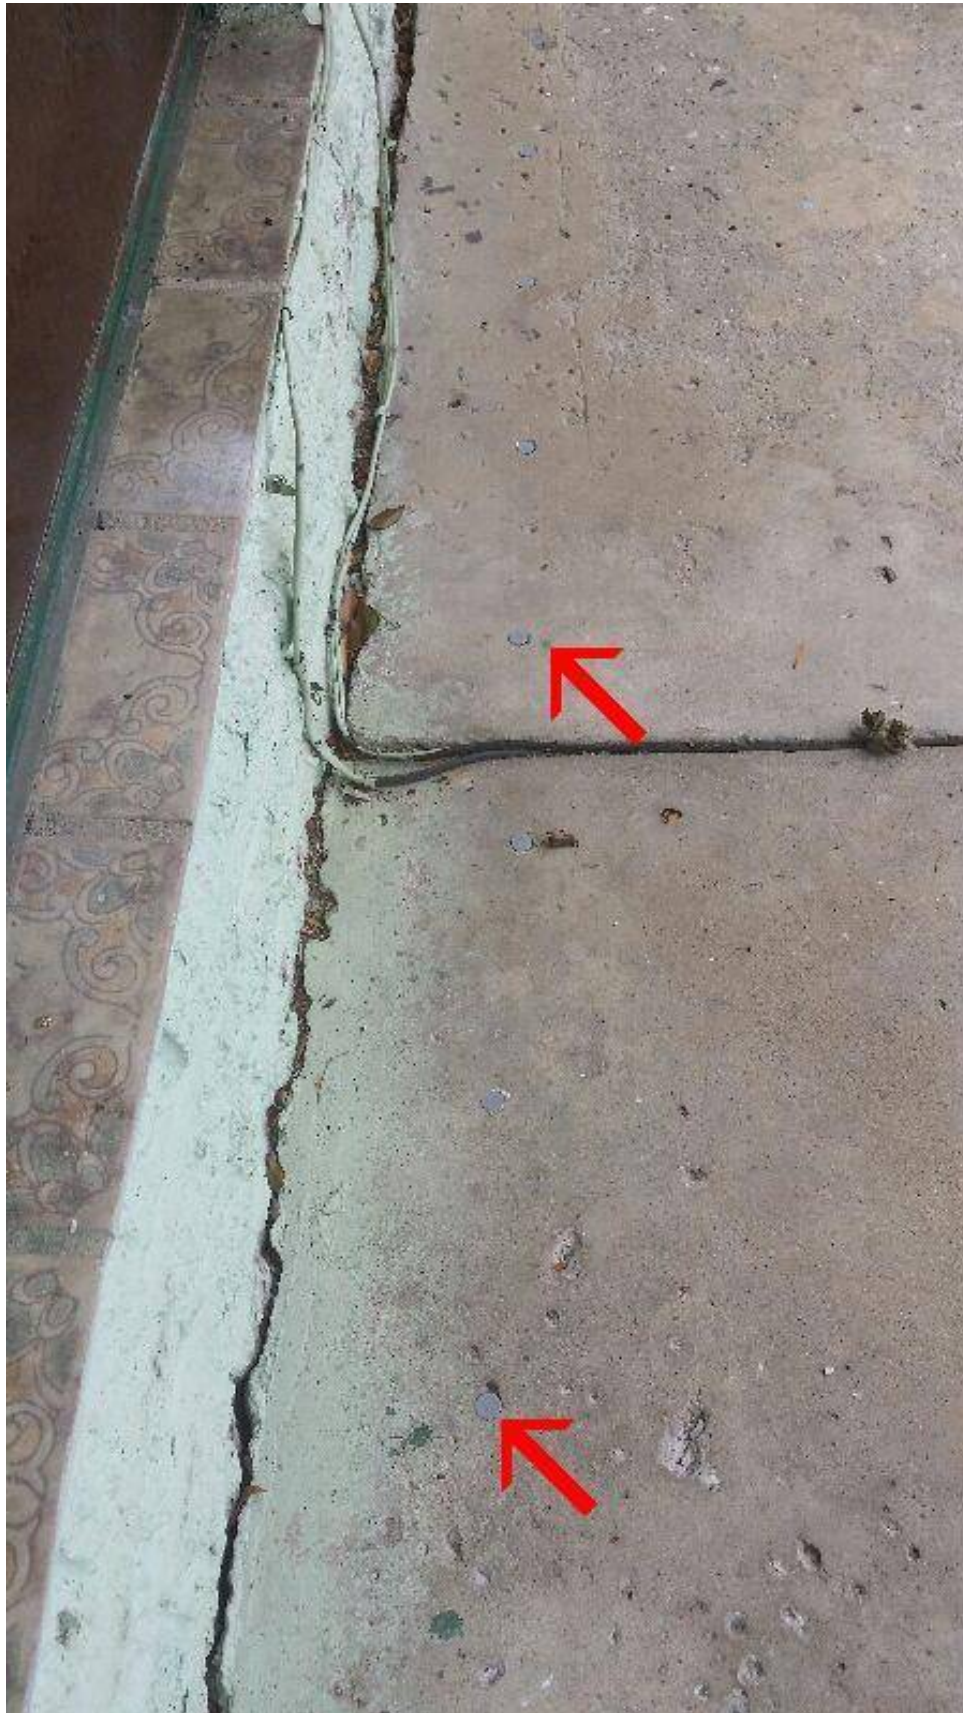
We found evidence that a termite treatment may have been carried out to this property. Where any evidence of a termite treatment or termite management system was noted, we strongly recommend any prospective purchaser research the documentation available in relation to this property and seek further information from the vendor in relation to any previous termite attack. The following evidence was found during our inspection. Evidence of drill holes were noted to concrete areas. Drill holes are an indicator

that the area or areas may have been treated by chemical injection in respect to termite control or protection. Timber pest damage may exist in concealed areas. You should have an invasive inspection carried out and have a builder determine the full extent of any damage.
