0813 Example Report 4 bldpst

# **VISUAL BUILDING and PEST INSPECTION REPORT**

## **Building and Pest**

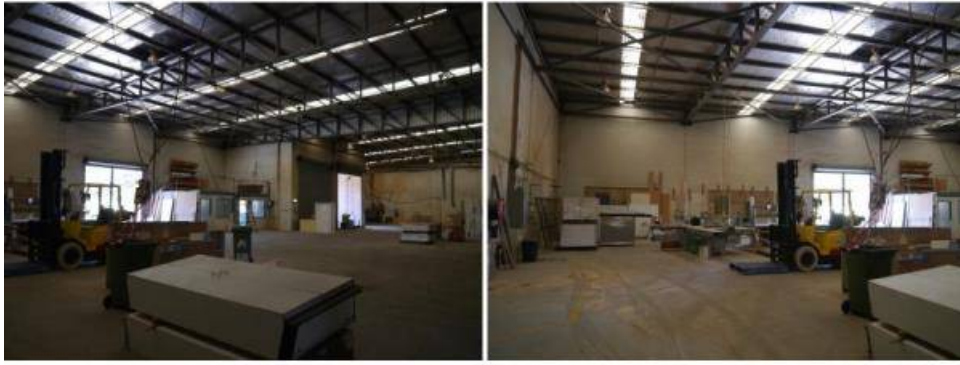
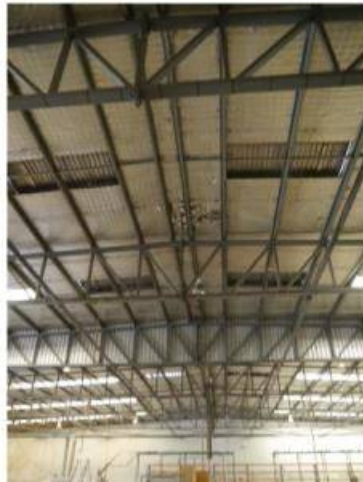
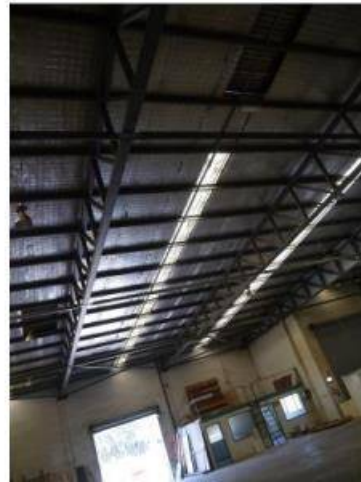
The roof is of pitched construction.

While we cannot view the roof sheet directly we assume due to the type of structure to roof sheet to be Metal decking: Sky lights to factory area are Fibreglass sheeting: This sheeting may require replacement.

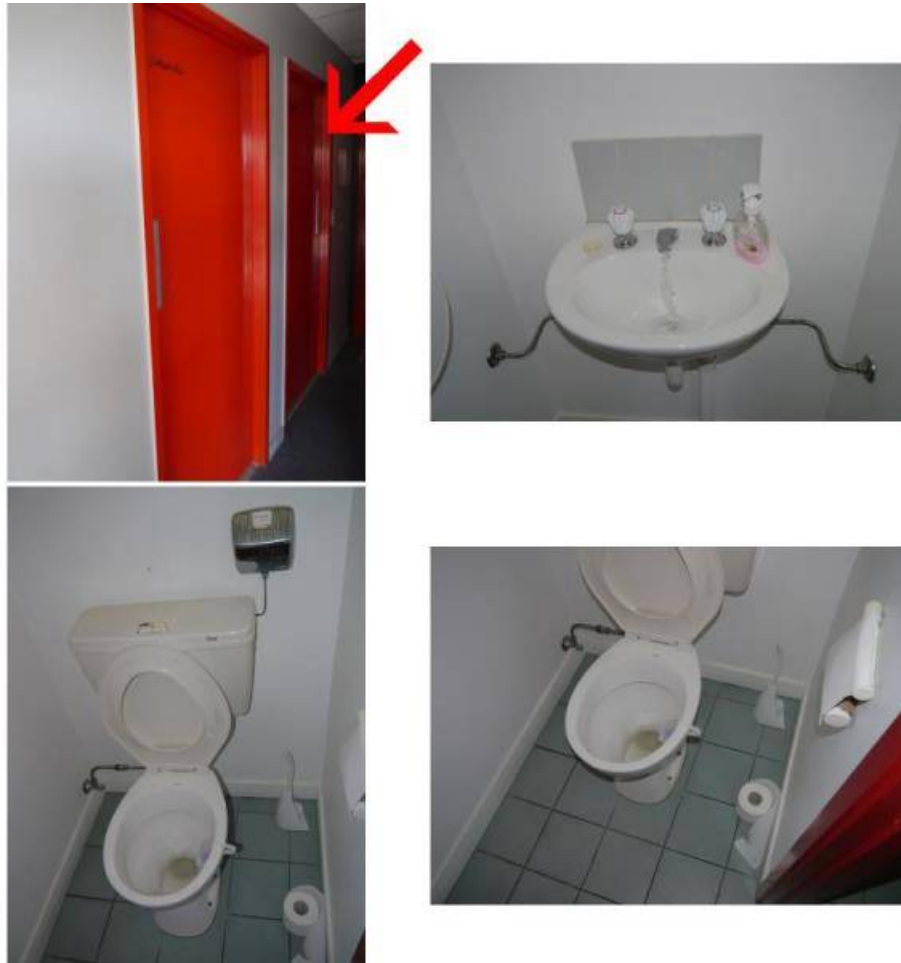
Office toilet #2 Upstairs.

Tiles are not present to wet areas. Recommend tiles be installed to prevent water penetration.

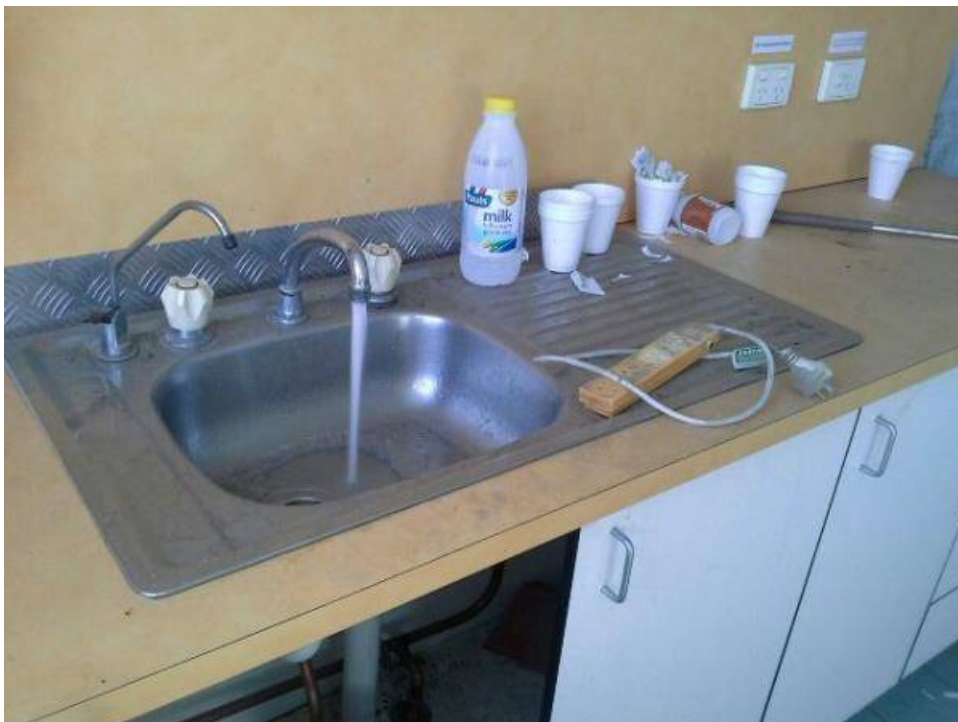
The sink and taps appear to be in a serviceable condition. The drain appears serviceable.

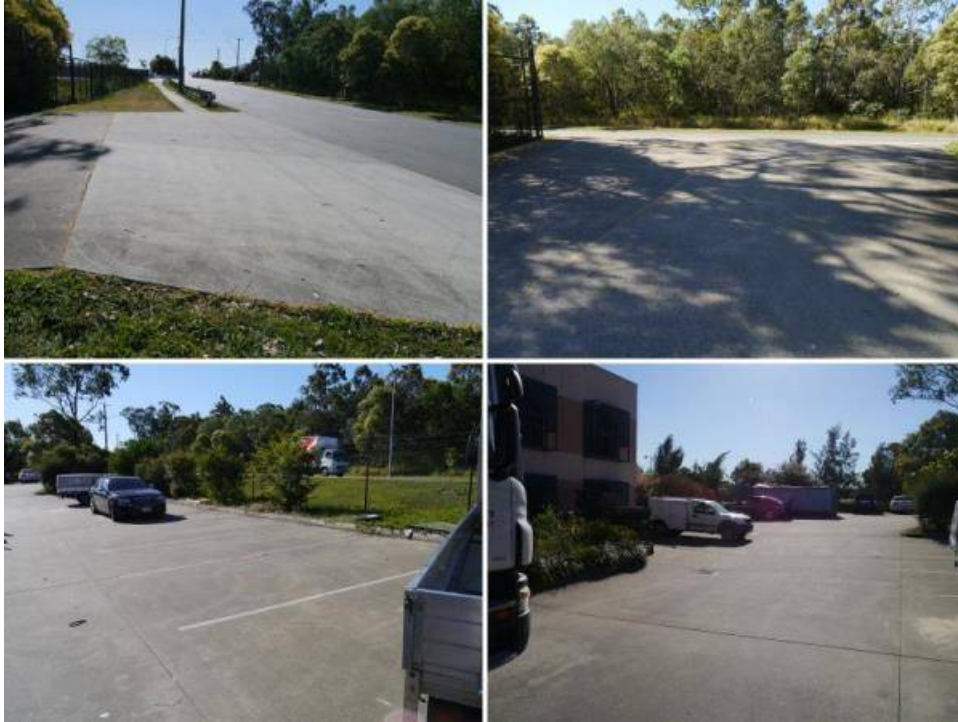
The concrete driveway stands in fair condition.

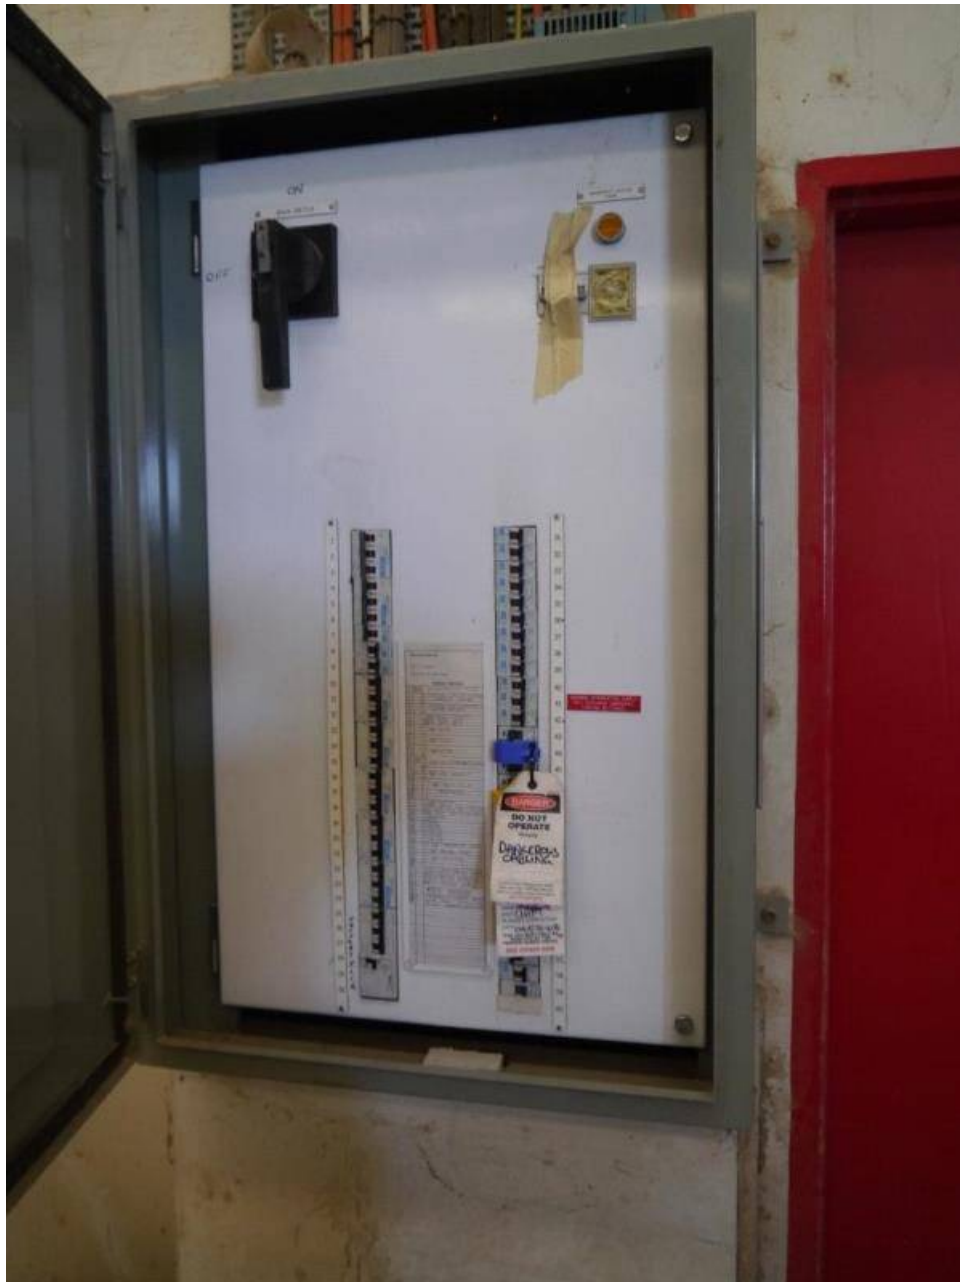
Smoke detectors are fitted however, the positioning, operation or adequacy was not tested and is not commented on. Residual current device (RCD) was noted in the electrical meter box. Functionality has not been tested, please contact a Licensed Electrical Contractor for testing to confirm proper installation and operation.

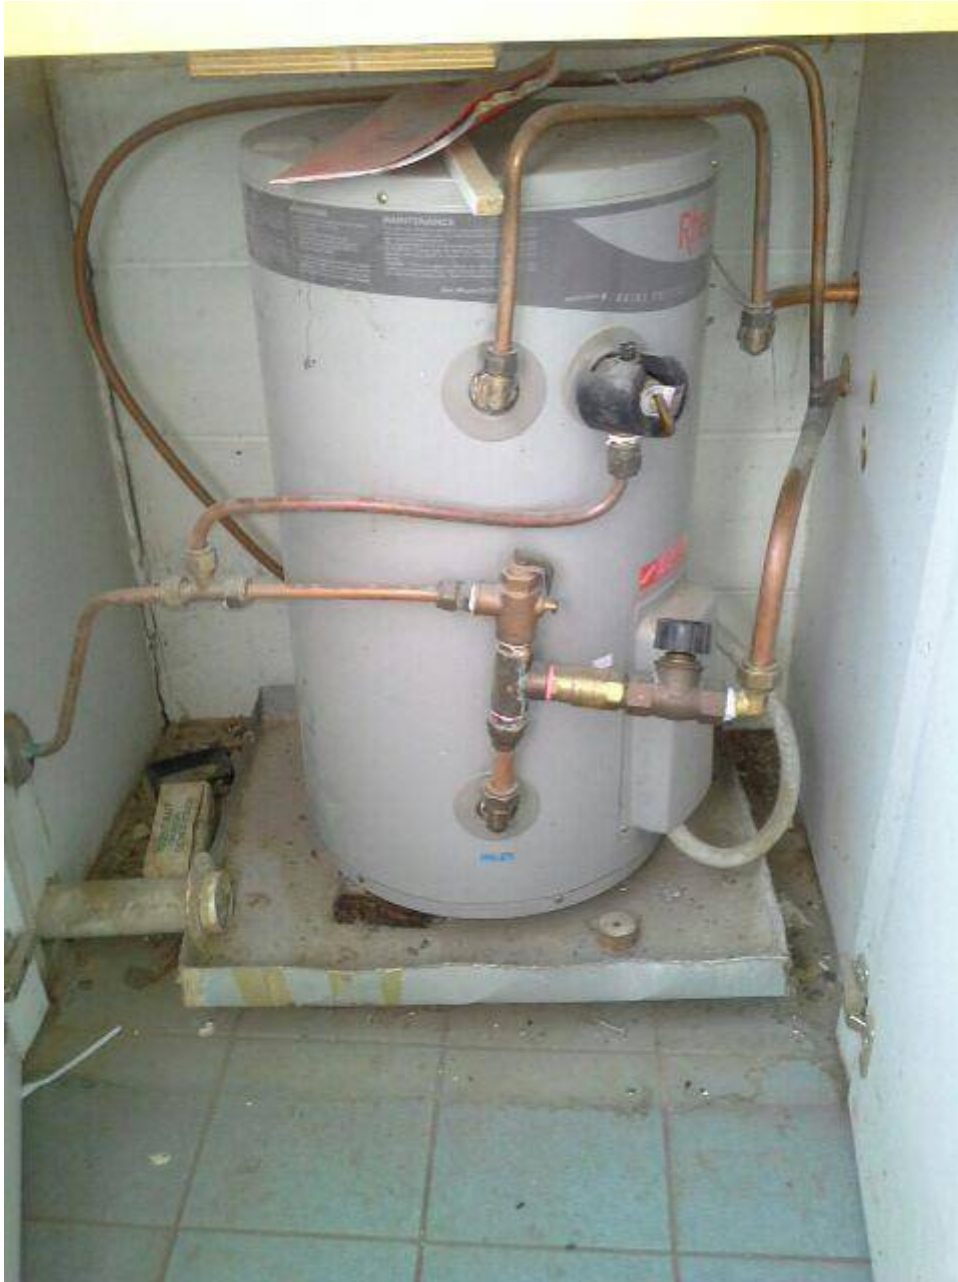
Mains electric hot water system: Mains pressure: Located in the kitchen cupboard: The hot water system appears to be in working condition. No specific tests other than running the hot water from a tap was carried out. No determination has been made as to the suitability or adequacy of the hot water system in relation to capacity or otherwise. There does not appear to be a temperature control valve fitted to the water heater. A burn/scald injury is possible. It is recommended that a temperature control valve be fitted by a Licensed water heating specialist.
